Test Report No: RJ-1822-2	Date: May 24, 2012
----------------------------------	---------------------------

SUBJECT: Flammability Testing to NFPA 286, Standard Methods of Fire Tests for Evaluating Contribution of Wall and Ceiling Interior Finish to Room Fire Growth – 2006 Edition.

SAMPLE ID: Client refers to samples received as **“Bautex Block with interior drywall”**. The samples were entered into our receiving system on 3/15/12 in good condition.

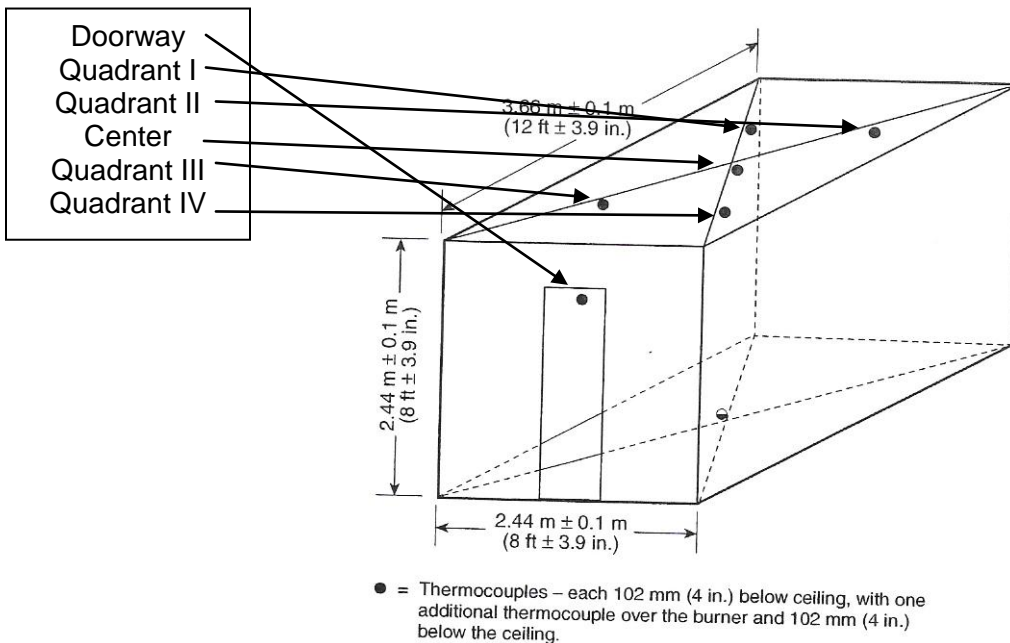
FIGURE 1. Thermocouple Locations

Thermocouple Placement:

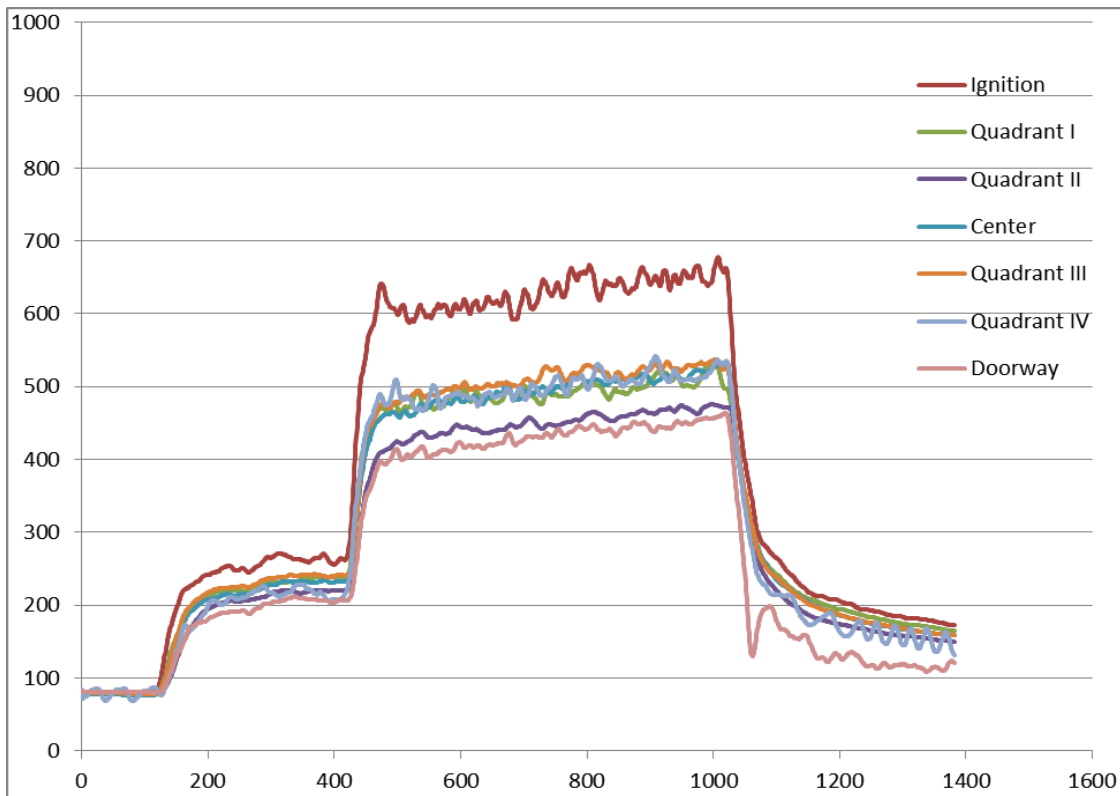
FIGURE 2. Temperature vs. Time

Doorway	463°F (239°C)
Center	532°F (278°C)
Quadrant I	530°F (277°C)
Quadrant II	476°F (247°C)
Ignition	677°F (358°C)
Quadrant III	537°F (281°C)
Quadrant IV	542°F (283°C)

AVERAGE UPPER LAYER TEMP – 398 °F (203 °C)

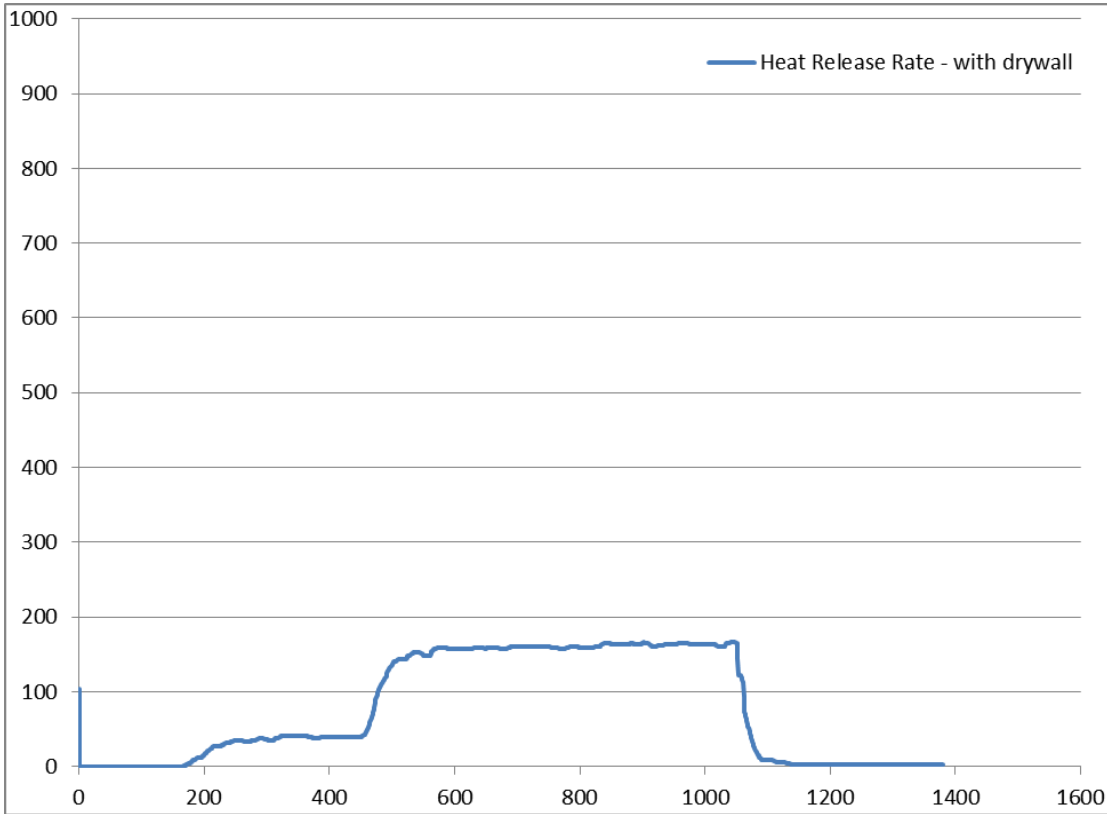
FIGURE 3. Heat Release Rate vs. Time

0-5 min average	40
5-15 min average	163
Peak Heat Release Rate	169 kW @ 08:22
Total Heat Released During 15 min Test	100.9

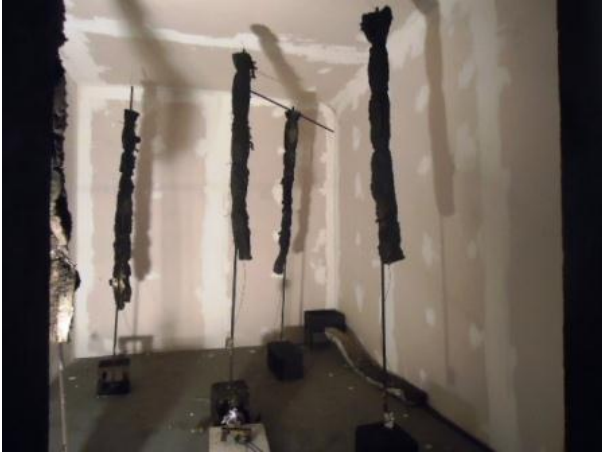
Ignition Corner

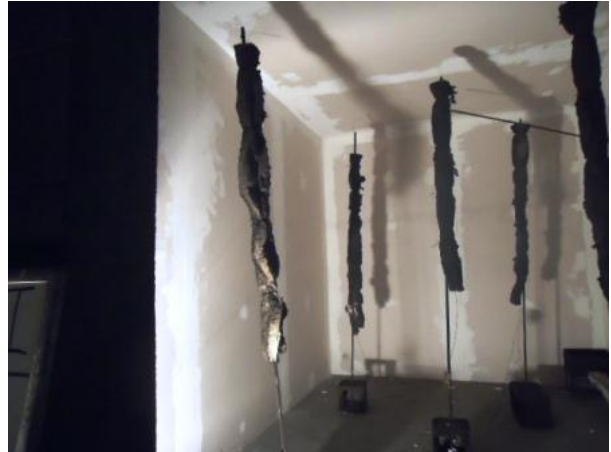
Opposite Corner

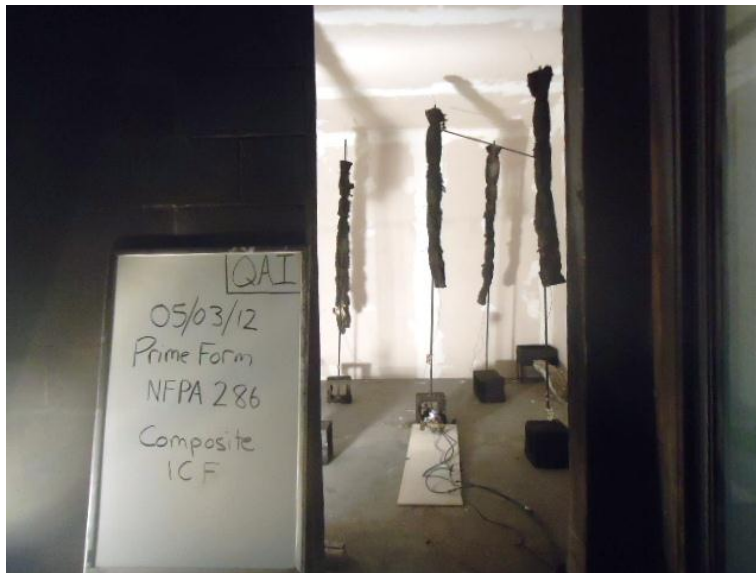
Overall

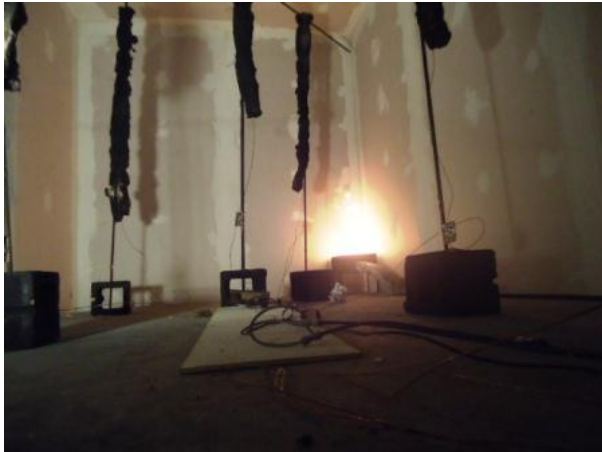
At Test Start

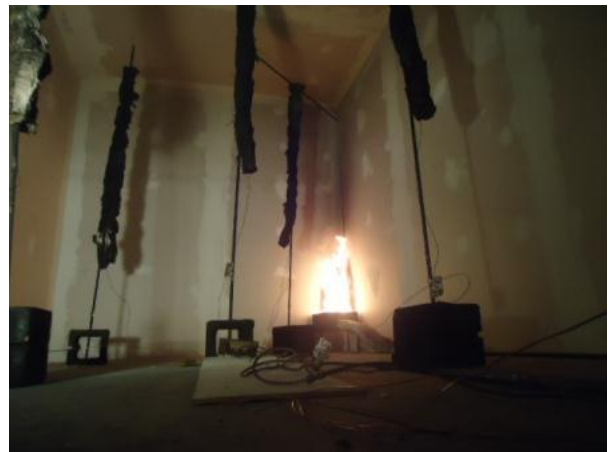
3 Minutes into Test

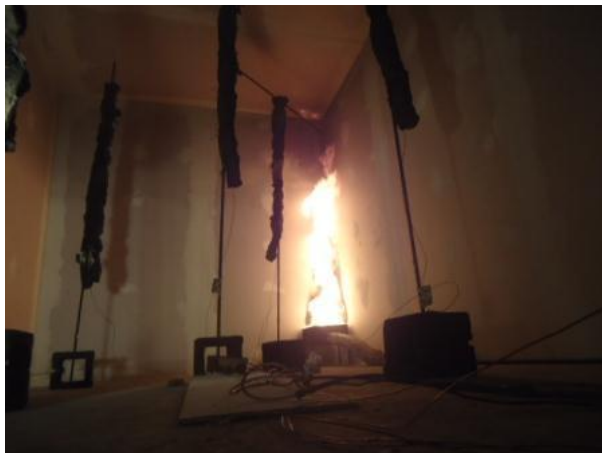
5 Minutes into Test

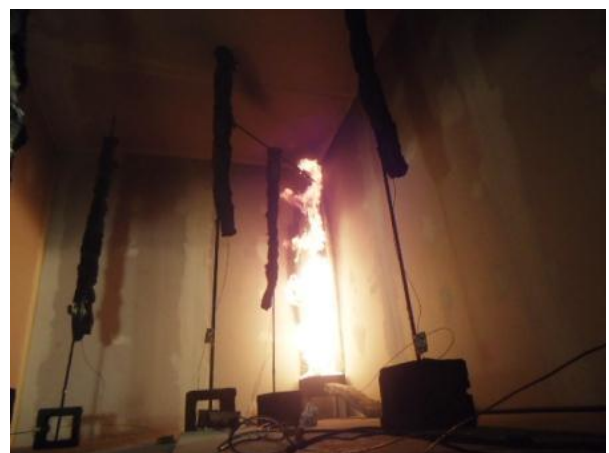
10 Minutes into Test

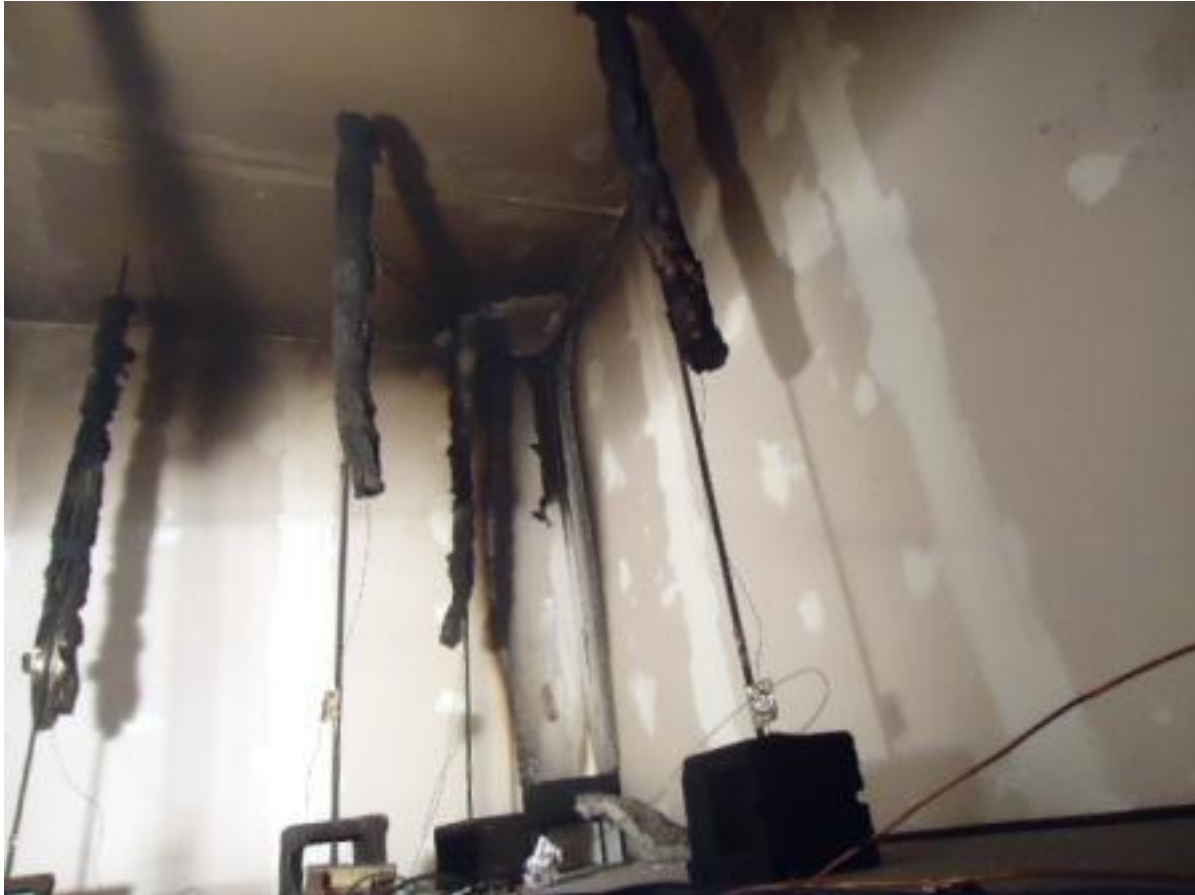
Immediately After Test

There was no flame spread noted on the drywall face of the sample throughout the test. There was very little, if any, visual damage to the test sample under the drywall as well. Damage to the drywall and the test cell was limited to flame contact and some slight discoloration where the smoke layer formed.
