**PERFORMANCE TEST REPORT
FOR
AIR LEAKAGE AND DURABILITY
OF BARRIER PRODUCTS
ASTM E 2357**

BAUTEX SYSTEMS

**SERIES/MODEL: AMB 20-WP
PRODUCT TYPE: Air Barrier System**

**Report No.: 97169.08-201-44
Test Dates: 01/29/10
Through: 02/04/10
Report Date: 01/03/13
Expiration Date: 01/29/14**

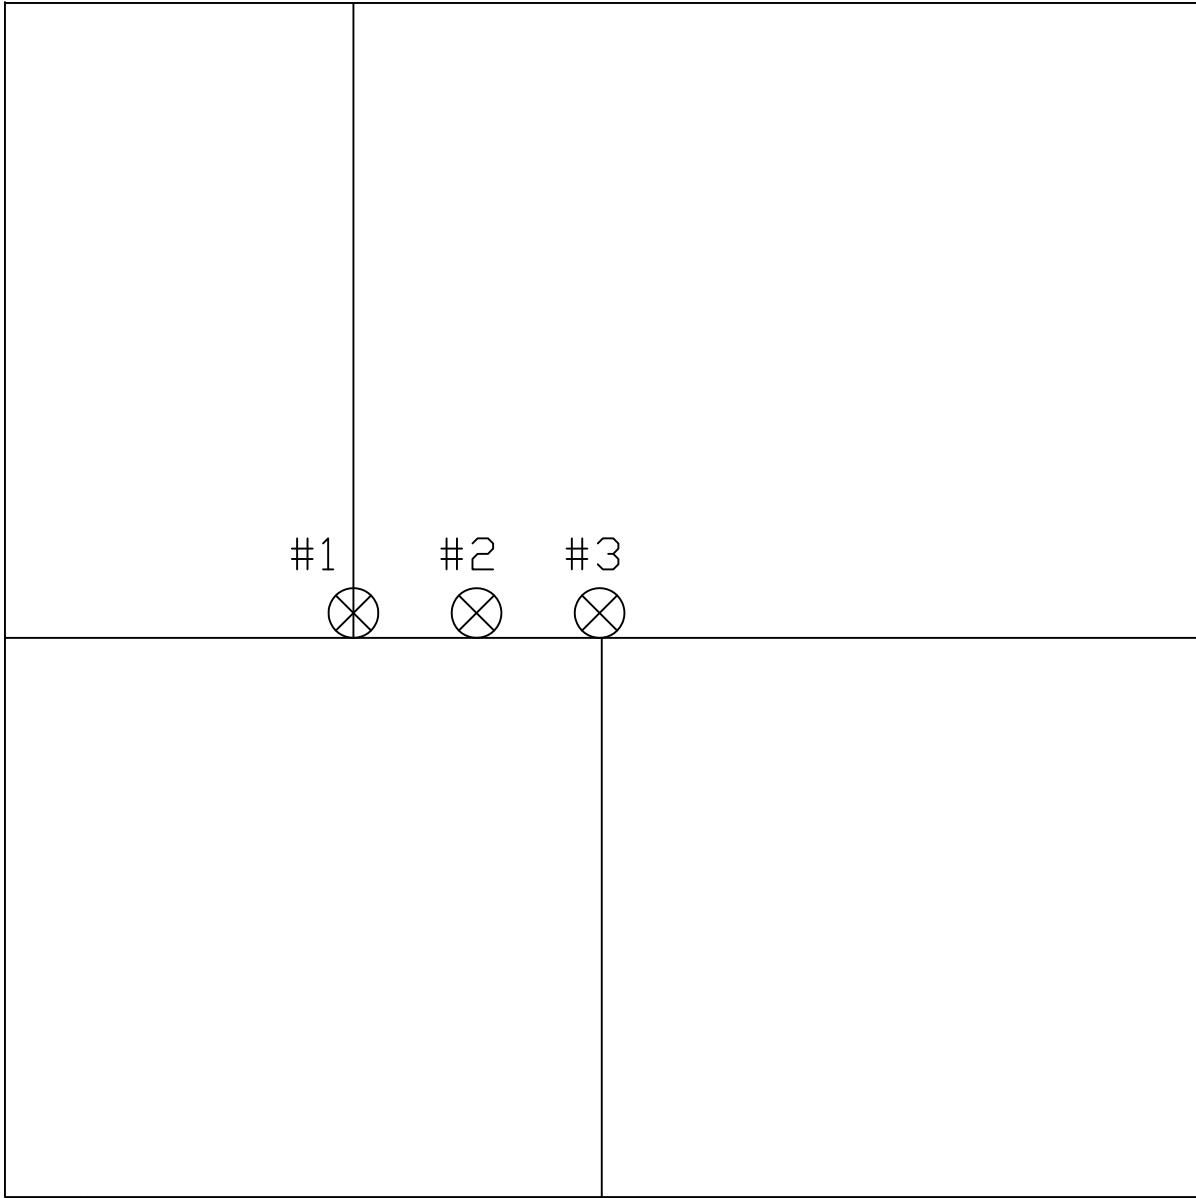
Note: See Architectural Testing Sketch #1 for indicator locations.

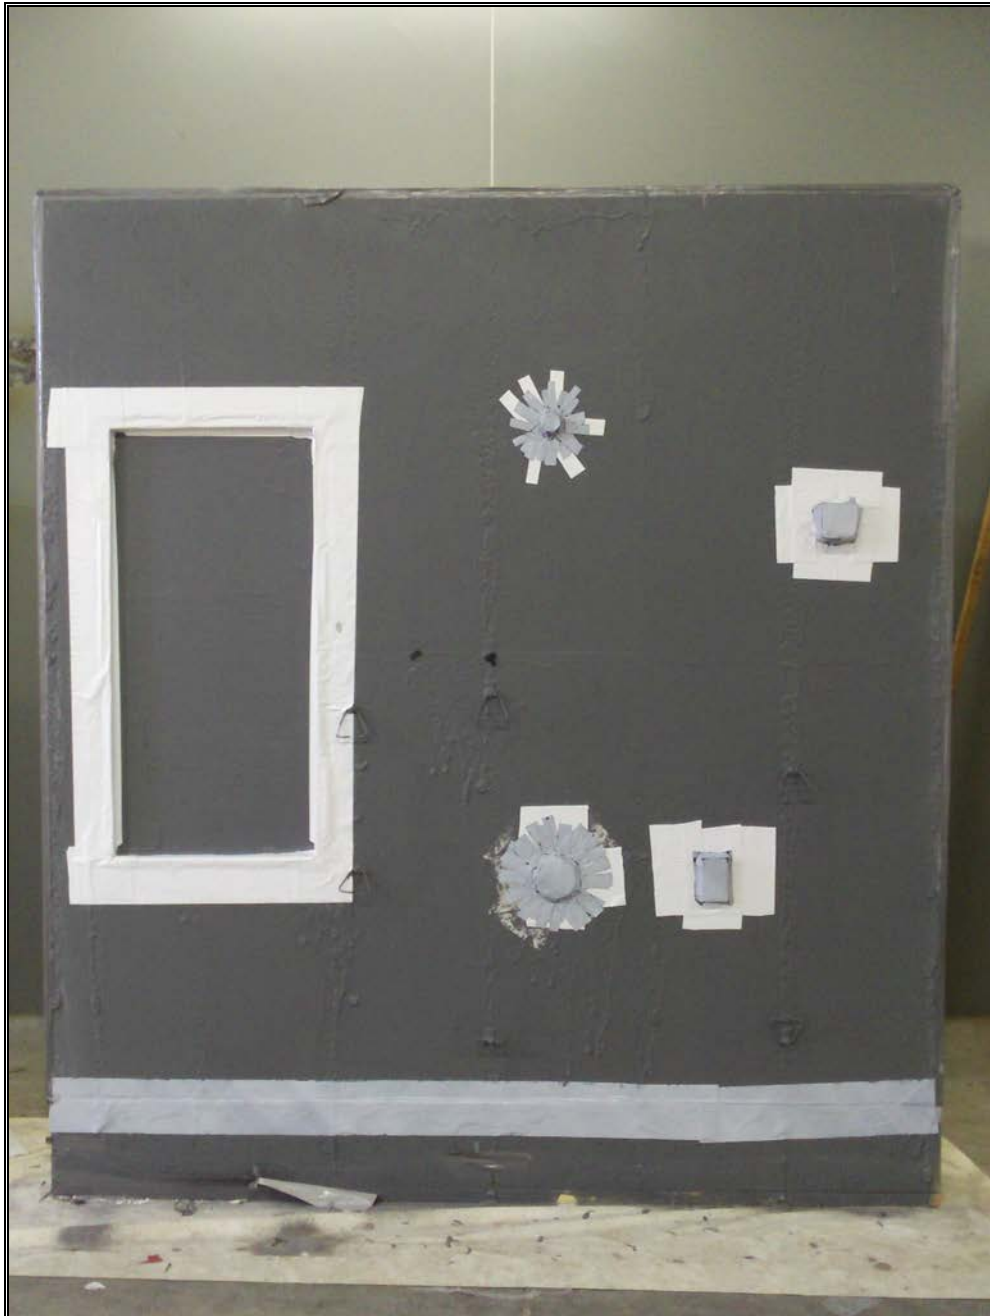
Photo No. 1
Penetrated Wall

Wall #1 Construction (Penetrated Wall): The wall was constructed of 2 x 6, 18 gauge steel studs spaced 16" on center and sheathed with nominal 1/2" thick DensGlass sheathing. The sheathing was secured with #8 x 1" long flat head screws spaced 8" on center. The wall was set atop a sill foam that was on a 12" thick by 12" high by 96" long concrete beam at the sill to represent an air barrier assembly/foundation wall interface.

Wall #1 Installation (Penetrated Wall): Sheathing joints were taped over with red sheathing tape. The assembly was then covered with Bautex Systems, AMB 20-WP primary air barrier material that was spray applied uniformly across the wall at a 32 mil wet thickness average. The assembly/foundation joint was taped over with an 8" self seal polyethylene faced bituthane tape. Penetrations in the assembly included a 24" by 36" window blank, a 4" by 4" duct, a 1-1/2" diameter PVC pipe, and two electrical box penetrations, one square and one octagon per ASTM E 2357. Six masonry anchors were additionally secured to the assembly with #8 x 2" screws after the AMB 20-WP air barrier was cured. The perimeter of the window blank was flashed with a white butyl tape self-adhering flashing. The remaining penetrations were sealed with a polyurethane sealant. Circular or octagonal penetrations were then flashed with two layers of polyethylene faced bituthane self-adhering flashing. Square penetrations were then flashed with one layer of polyethylene faced bituthane self-adhering flashing. The dry thickness of the Bautex Systems, AMB 20-WP primary air barrier material was 22 mil.

A chamber constructed of nominal lumber and ply wood was applied to the interior of the wall construction secured with plywood sides and top rail. The bottom was secured to the foundation with masonry screws. The chamber was sealed to the assembly with duct tape (Reference Photo #1 for details).

Wall #1 - Commercial Penetrated Wall

Test Results	
Title of Test	Pressure	Air Infiltration	Air Exfiltration
Air Infiltration (Phase I)	25 Pa (0.52 psf)	0.0012 cfm/ft ² (0.006 L/s/m ²)	0.0002 cfm/ft ² (0.001 L/s/m ²)
	50 Pa (1.04 psf)	0.0016 cfm/ft ² (0.008 L/s/m ²)	0.0005 cfm/ft ² (0.003 L/s/m ²)
	75 Pa (1.57 psf)	0.0025 cfm/ft ² (0.013 L/s/m ²)	0.0009 cfm/ft ² (0.005 L/s/m ²)
	100 Pa (2.09 psf)	0.0033 cfm/ft ² (0.017 L/s/m ²)	0.0008 cfm/ft ² (0.004 L/s/m ²)
	150 Pa (3.13 psf)	0.0041 cfm/ft ² (0.021 L/s/m ²)	0.0011 cfm/ft ² (0.006 L/s/m ²)
	250 Pa (5.22 psf)	0.0047 cfm/ft ² (0.024 L/s/m ²)	0.0016 cfm/ft ² (0.008 L/s/m ²)
	300 Pa (6.27 psf)	0.0033 cfm/ft ² (0.017 L/s/m ²)	0.0011 cfm/ft ² (0.006 L/s/m ²)

Title of Test	Pressure	Test Results
Deformation (10 second load)	±100 Pa (±2.09 psf)	No damage
	±200 Pa (±4.18 psf)	No damage
	±300 Pa (±6.27 psf)	No damage
	±400 Pa (±8.36 psf)	No damage
	±500 Pa (±10.45 psf)	No damage
Deformation (60 minute load)	±600 Pa (±12.54 psf)	No damage
Cyclic Loading (2000 cycles)	±800 Pa (±16.72 psf)	No damage
Gust Loading (3 second load)	±1200 Pa (±25.08 psf)	No damage

Test Results	
Title of Test	Pressure	Air Infiltration	Air Exfiltration
Air Infiltration (Phase II)	25 Pa (0.52 psf)	0.0008 cfm/ft ² (0.004 L/s/m ²)	0.0002 cfm/ft ² (0.0001 L/s/m ²)
	50 Pa (1.04 psf)	0.0012 cfm/ft ² (0.006 L/s/m ²)	0.0012 cfm/ft ² (0.006 L/s/m ²)
	75 Pa (1.57 psf)	0.0022 cfm/ft ² (0.011 L/s/m ²)	0.0012 cfm/ft ² (0.006 L/s/m ²)
	100 Pa (2.09 psf)	0.0020 cfm/ft ² (0.010 L/s/m ²)	0.0016 cfm/ft ² (0.008 L/s/m ²)
	150 Pa (3.13 psf)	0.0028 cfm/ft ² (0.014 L/s/m ²)	0.0019 cfm/ft ² (0.010 L/s/m ²)
	250 Pa (5.22 psf)	0.0028 cfm/ft ² (0.014 L/s/m ²)	0.0028 cfm/ft ² (0.014 L/s/m ²)
	300 Pa (6.27 psf)	0.0033 cfm/ft ² (0.017 L/s/m ²)	0.0048 cfm/ft ² (0.024 L/s/m ²)

Title of Test	Pressure	Test Results (inch)		
		#1	#2	#3
Wind Pressure Loading (10 second load)	+1440 Pa (+30.09 psf)	0.04	0.11	0.16
	-1440 Pa (-30.09 psf)	0.36	0.39	0.40

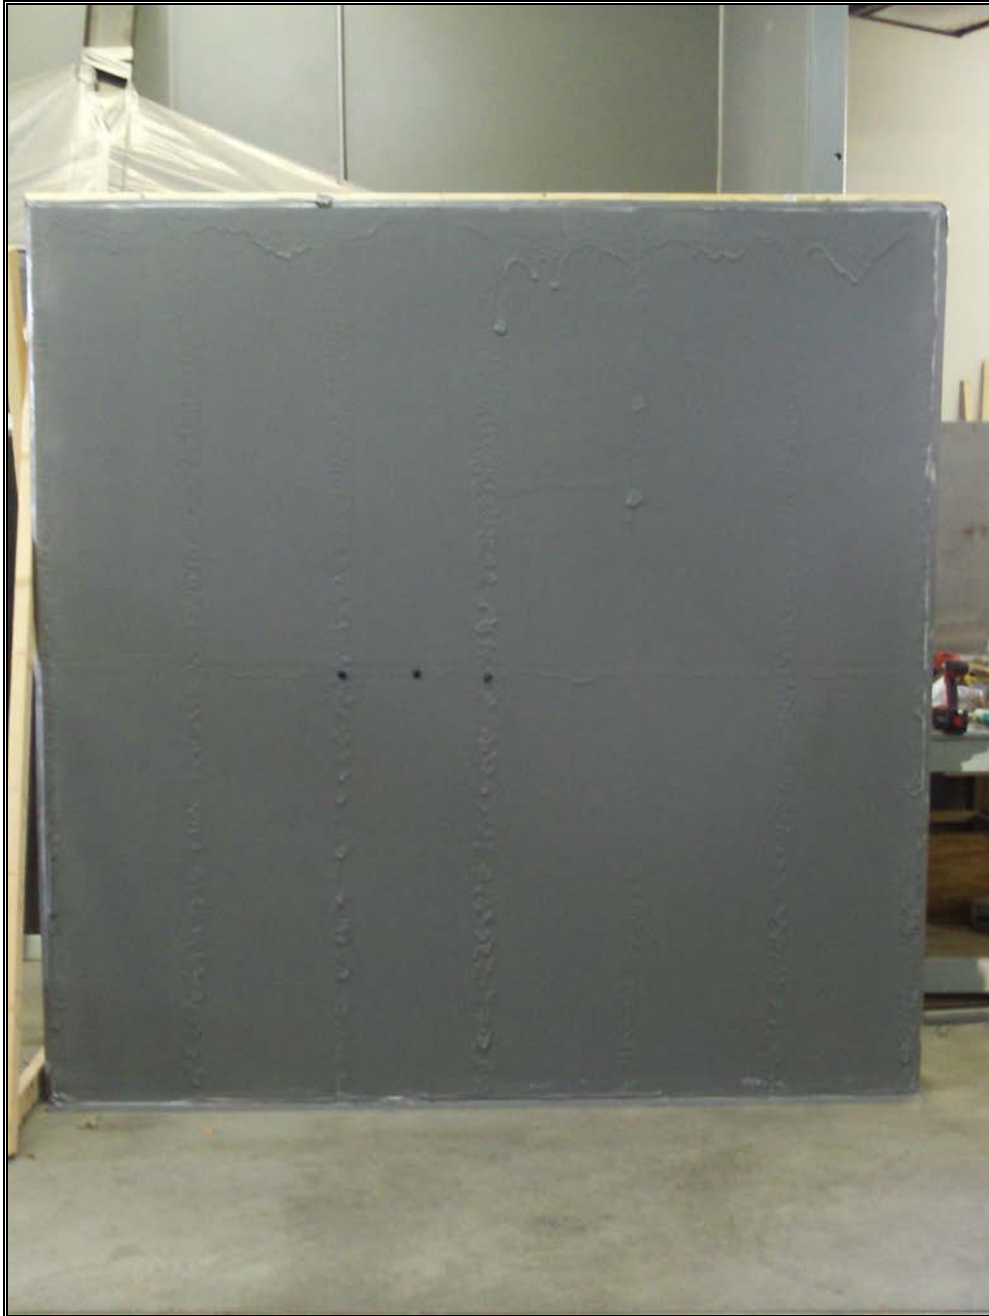
**Photo No. 2
Control Wall**

Wall #2 Construction (Control Wall): The wall was constructed of 2 x 6, 18 gauge steel studs spaced 16" on center and sheathed with nominal 1/2" thick DensGlass sheathing. The sheathing was secured with #8 x 1" long flat head screws spaced 8" on center.

Wall #2 Installation (Control Wall): Sheathing joints were taped over with red sheathing tape. The assembly was then covered with Bautex Systems, AMB 20-WP primary air barrier material that was spray applied uniformly across the wall at a 32 mil wet thickness average. The dry thickness of the AMB 20-WP primary air barrier material was 22 mil (Reference Photo #2 for details).

Wall #2 - Commercial Control Wall

Test Results	
Title of Test	Pressure	Air Infiltration	Air Exfiltration
Air Infiltration (Phase I)	25 Pa (0.52 psf)	0.0041 cfm/ft ² (0.020 L/s/m ²)	0.0005 cfm/ft ² (0.002 L/s/m ²)
	50 Pa (1.04 psf)	0.0056 cfm/ft ² (0.028 L/s/m ²)	0.0016 cfm/ft ² (0.008 L/s/m ²)
	75 Pa (1.57 psf)	0.0067 cfm/ft ² (0.034 L/s/m ²)	0.0017 cfm/ft ² (0.009 L/s/m ²)
	100 Pa (2.09 psf)	0.0069 cfm/ft ² (0.035 L/s/m ²)	0.0027 cfm/ft ² (0.014 L/s/m ²)
	150 Pa (3.13 psf)	0.0078 cfm/ft ² (0.040 L/s/m ²)	0.0031 cfm/ft ² (0.016 L/s/m ²)
	250 Pa (5.22 psf)	0.0116 cfm/ft ² (0.059 L/s/m ²)	0.0058 cfm/ft ² (0.029 L/s/m ²)
	300 Pa (6.27 psf)	0.0136 cfm/ft ² (0.069 L/s/m ²)	0.0077 cfm/ft ² (0.039 L/s/m ²)

Title of Test	Pressure	Test Results
Deformation (10 second load)	±100 Pa (±2.09 psf)	No damage
	±200 Pa (±4.18 psf)	No damage
	±300 Pa (±6.27 psf)	No damage
	±400 Pa (±8.36 psf)	No damage
	±500 Pa (±10.45 psf)	No damage
Deformation (60 minute load)	±600 Pa (±12.54 psf)	No damage
Cyclic Loading (2000 cycles)	±800 Pa (±16.72 psf)	No damage
Gust Loading (3 second load)	±1200 Pa (±25.08 psf)	No damage

Test Results	
Title of Test	Pressure	Air Infiltration	Air Exfiltration
Air Infiltration (Phase II)	25 Pa (0.52 psf)	0.0023 cfm/ft ² (0.012 L/s/m ²)	0.0017 cfm/ft ² (0.009 L/s/m ²)
	50 Pa (1.04 psf)	0.0038 cfm/ft ² (0.019 L/s/m ²)	0.0033 cfm/ft ² (0.017 L/s/m ²)
	75 Pa (1.57 psf)	0.0047 cfm/ft ² (0.024 L/s/m ²)	0.0041 cfm/ft ² (0.021 L/s/m ²)
	100 Pa (2.09 psf)	0.0056 cfm/ft ² (0.028 L/s/m ²)	0.0048 cfm/ft ² (0.024 L/s/m ²)
	150 Pa (3.13 psf)	0.0059 cfm/ft ² (0.030 L/s/m ²)	0.0066 cfm/ft ² (0.034 L/s/m ²)
	250 Pa (5.22 psf)	0.0039 cfm/ft ² (0.019 L/s/m ²)	0.0072 cfm/ft ² (0.037 L/s/m ²)
	300 Pa (6.27 psf)	0.0030 cfm/ft ² (0.015 L/s/m ²)	0.0070 cfm/ft ² (0.036 L/s/m ²)

Title of Test	Pressure	Test Results (inch)		
		#1	#2	#3
Wind Pressure Loading (10 second load)	+1440 Pa (+30.09 psf)	0.36	0.40	0.38
	-1440 Pa (-30.09 psf)	0.65	0.66	0.65
