**PERFORMANCE TEST REPORT  
FOR  
AIR LEAKAGE AND DURABILITY  
OF BARRIER PRODUCTS  
ASTM E 2357**

**SERIES/MODEL: AMB 20-WN  
PRODUCT TYPE: Air Barrier System**

**Report No.: A1709.04-201-44  
Test Dates: 07/19/10  
Through: 07/22/10  
Report Date: 01/03/13  
Record Retention Date: 07/19/14**

**Project Summary:** Architectural Testing, Inc. was contracted by Bautex Systems to conduct air leakage and durability tests on an air barrier assembly in accordance with ASTM E 2357, *Standard Test Method for Determining Air Leakage of Air Barrier Assemblies*.

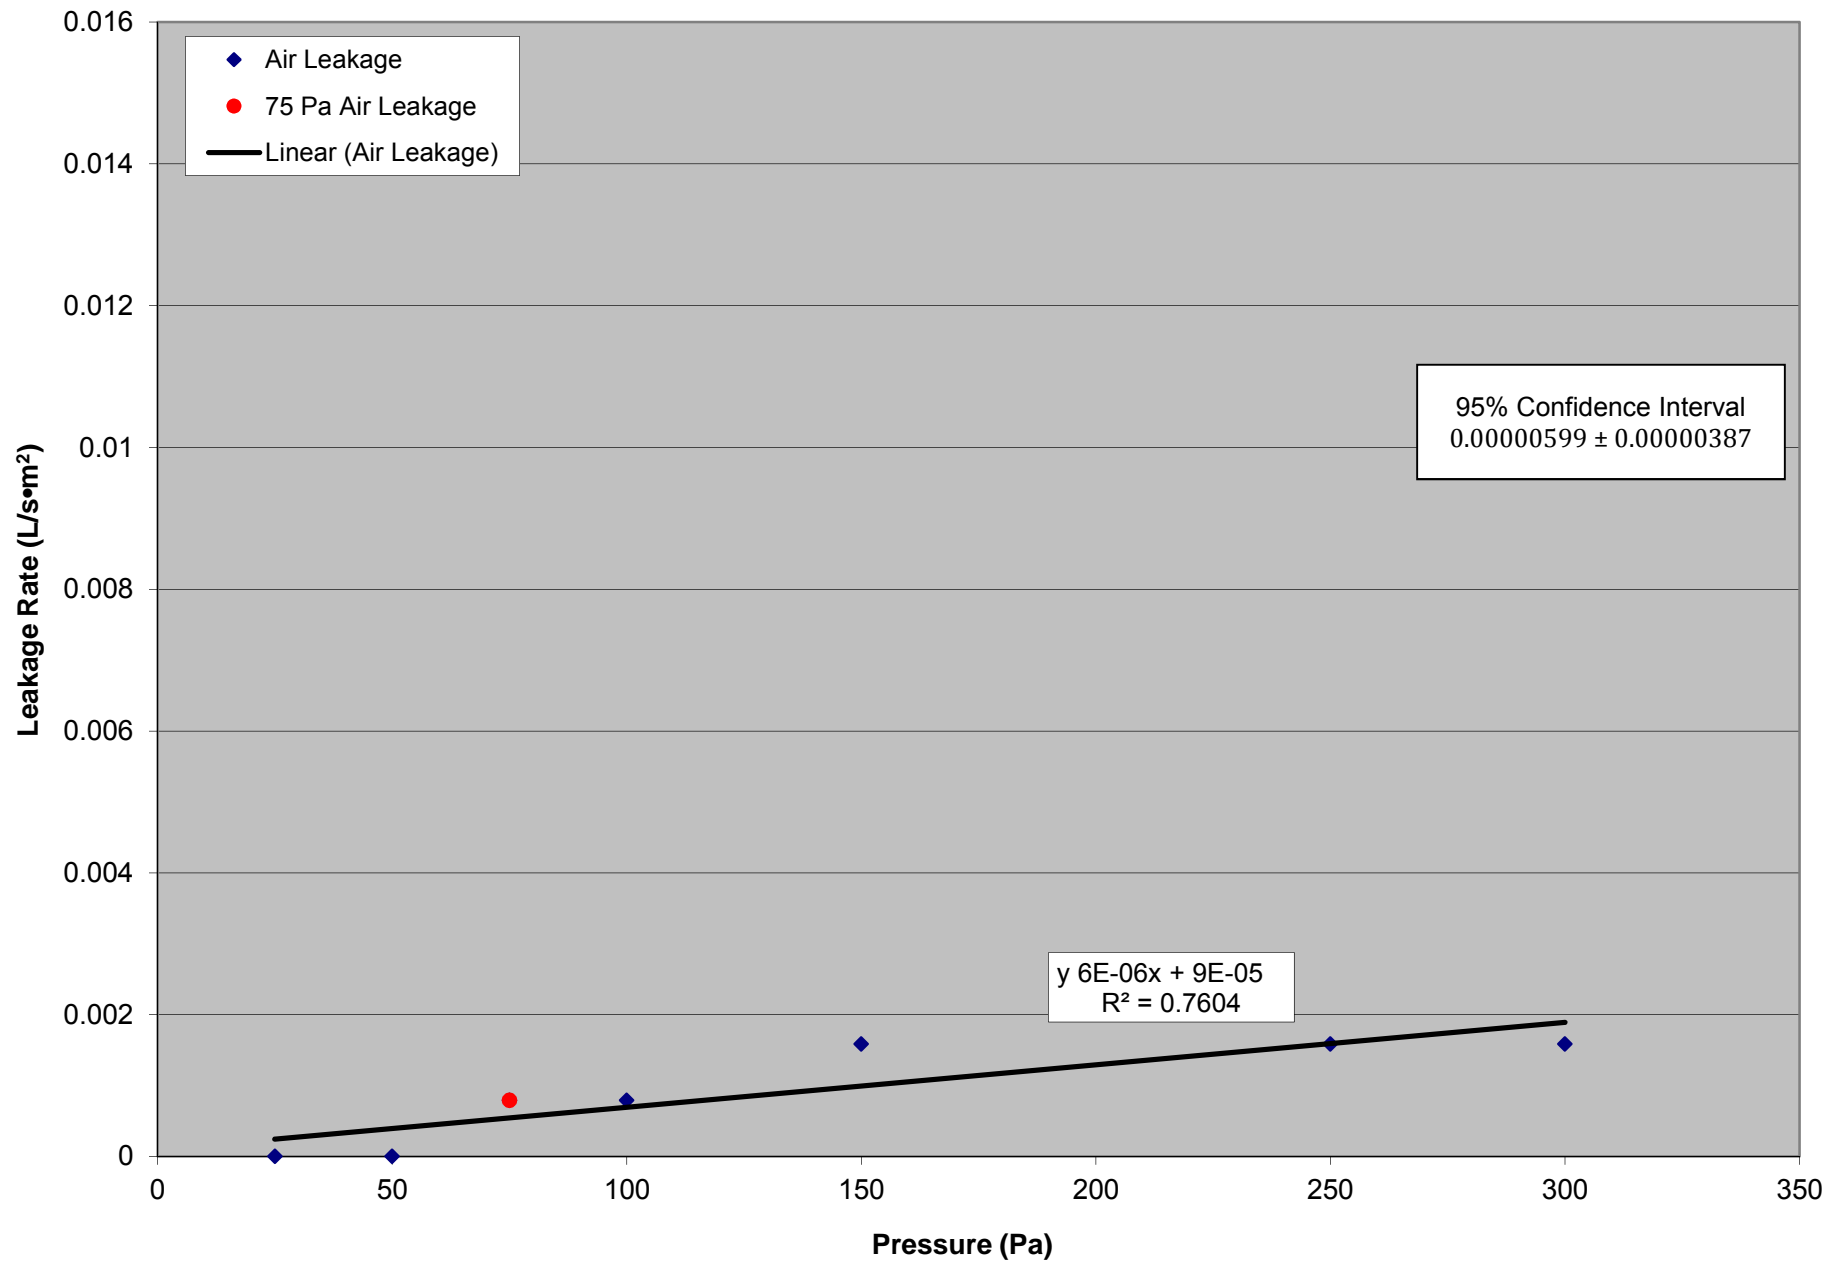
### Specimen #1 - Air Infiltration (Before loading sequence)

Test Results	
Title of Test	Pressure	Air Infiltration	Air Exfiltration
Air Infiltration (Phase I)	25 Pa (0.52 psf)	0.0000 cfm/ft <sup>2</sup> (0.000 L/s/m <sup>2</sup> )	0.0003 cfm/ft <sup>2</sup> (0.002 L/s/m <sup>2</sup> )
	50 Pa (1.04 psf)	0.0000 cfm/ft <sup>2</sup> (0.000 L/s/m <sup>2</sup> )	0.0003 cfm/ft <sup>2</sup> (0.002 L/s/m <sup>2</sup> )
	<b>75 Pa (1.57 psf)</b>	<b>0.0002 cfm/ft<sup>2</sup> (0.001 L/s/m<sup>2</sup>)</b>	<b>0.0003 cfm/ft<sup>2</sup> (0.002 L/s/m<sup>2</sup>)</b>
	100 Pa (2.09 psf)	0.0002 cfm/ft <sup>2</sup> (0.001 L/s/m <sup>2</sup> )	0.0005 cfm/ft <sup>2</sup> (0.002 L/s/m <sup>2</sup> )
	150 Pa (3.13 psf)	0.0003 cfm/ft <sup>2</sup> (0.002 L/s/m <sup>2</sup> )	0.0009 cfm/ft <sup>2</sup> (0.005 L/s/m <sup>2</sup> )
	250 Pa (5.22 psf)	0.0003 cfm/ft <sup>2</sup> (0.002 L/s/m <sup>2</sup> )	0.0016 cfm/ft <sup>2</sup> (0.008 L/s/m <sup>2</sup> )
	300 Pa (6.27 psf)	0.0003 cfm/ft <sup>2</sup> (0.002 L/s/m <sup>2</sup> )	0.0011 cfm/ft <sup>2</sup> (0.006 L/s/m <sup>2</sup> )

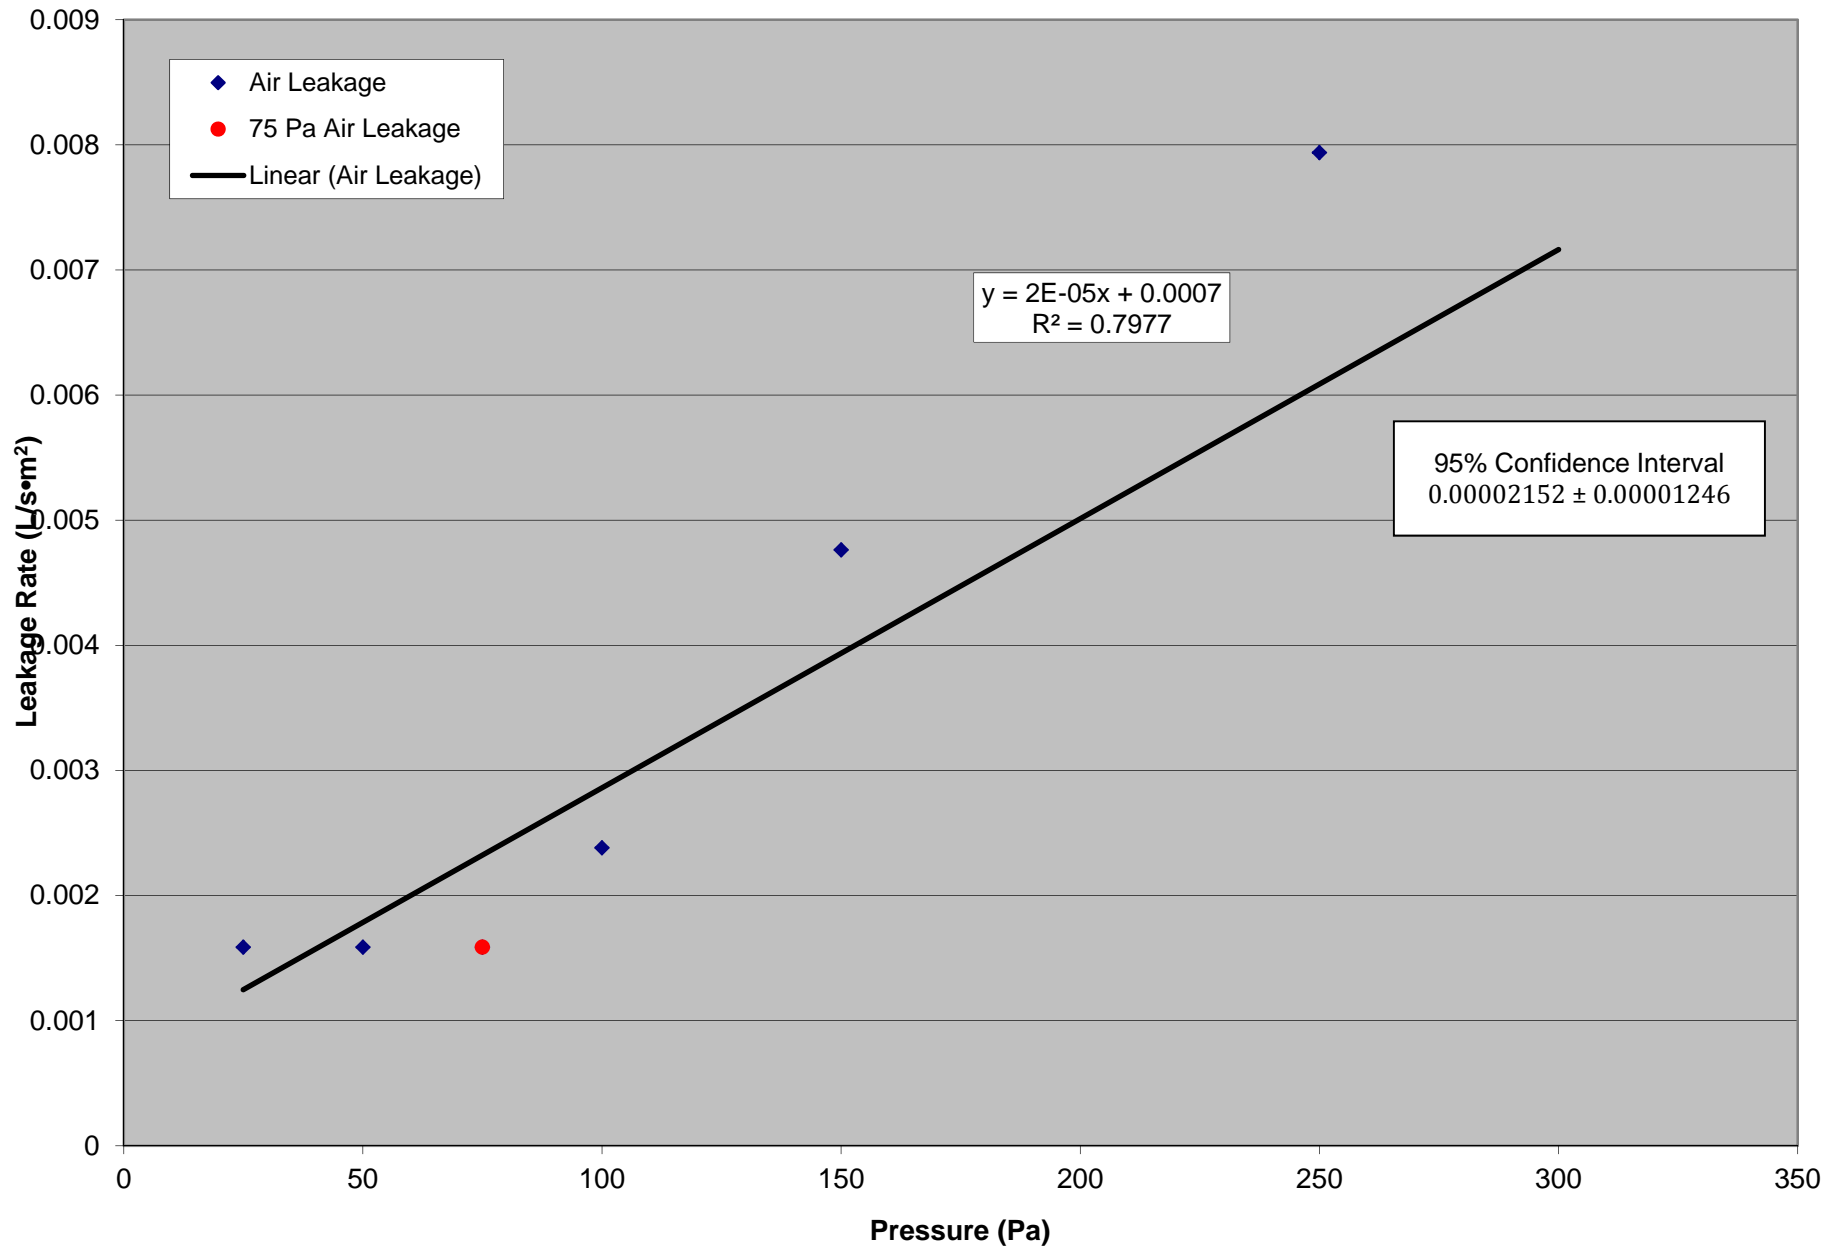
### Specimen #1 - Air Exfiltration (Before loading sequence)

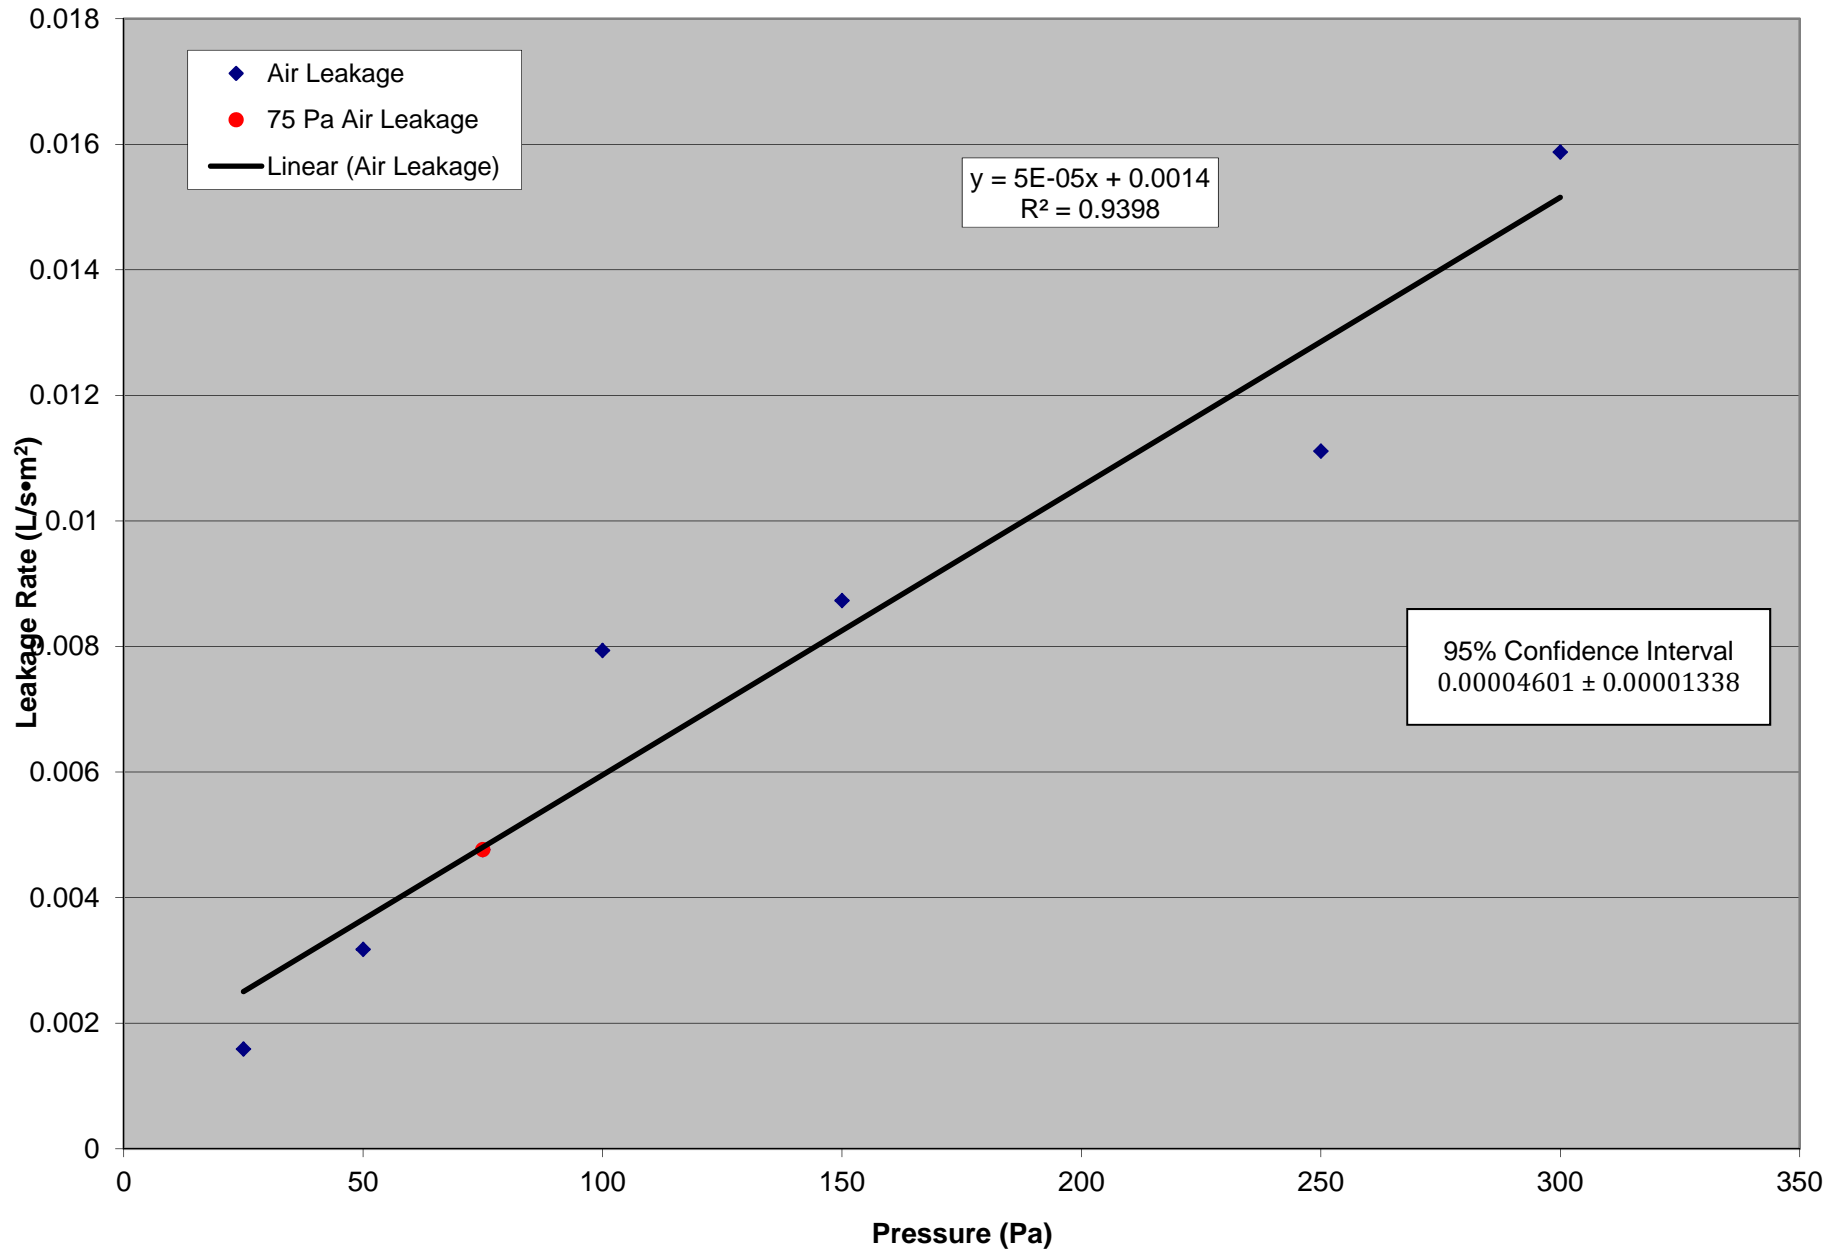
### Specimen #1 - Air Infiltration (After loading sequence)

Test Results	
Title of Test	Pressure	Air Infiltration	Air Exfiltration
Air Infiltration (Phase II)	25 Pa (0.52 psf)	0.0003 cfm/ft <sup>2</sup> (0.002 L/s/m <sup>2</sup> )	0.0008 cfm/ft <sup>2</sup> (0.004 L/s/m <sup>2</sup> )
	50 Pa (1.04 psf)	0.0006 cfm/ft <sup>2</sup> (0.003 L/s/m <sup>2</sup> )	0.0010 cfm/ft <sup>2</sup> (0.006 L/s/m <sup>2</sup> )
	<b>75 Pa (1.57 psf)</b>	<b>0.0009 cfm/ft<sup>2</sup> (0.005 L/s/m<sup>2</sup>)</b>	<b>0.0013 cfm/ft<sup>2</sup> (0.006 L/s/m<sup>2</sup>)</b>
	100 Pa (2.09 psf)	0.0016 cfm/ft <sup>2</sup> (0.008 L/s/m <sup>2</sup> )	0.0014 cfm/ft <sup>2</sup> (0.007 L/s/m <sup>2</sup> )
	150 Pa (3.13 psf)	0.0017 cfm/ft <sup>2</sup> (0.009 L/s/m <sup>2</sup> )	0.0014 cfm/ft <sup>2</sup> (0.007 L/s/m <sup>2</sup> )
	250 Pa (5.22 psf)	0.0022 cfm/ft <sup>2</sup> (0.011 L/s/m <sup>2</sup> )	0.0016 cfm/ft <sup>2</sup> (0.008 L/s/m <sup>2</sup> )
	300 Pa (6.27 psf)	0.0031 cfm/ft <sup>2</sup> (0.016 L/s/m <sup>2</sup> )	0.0008 cfm/ft <sup>2</sup> (0.004 L/s/m <sup>2</sup> )

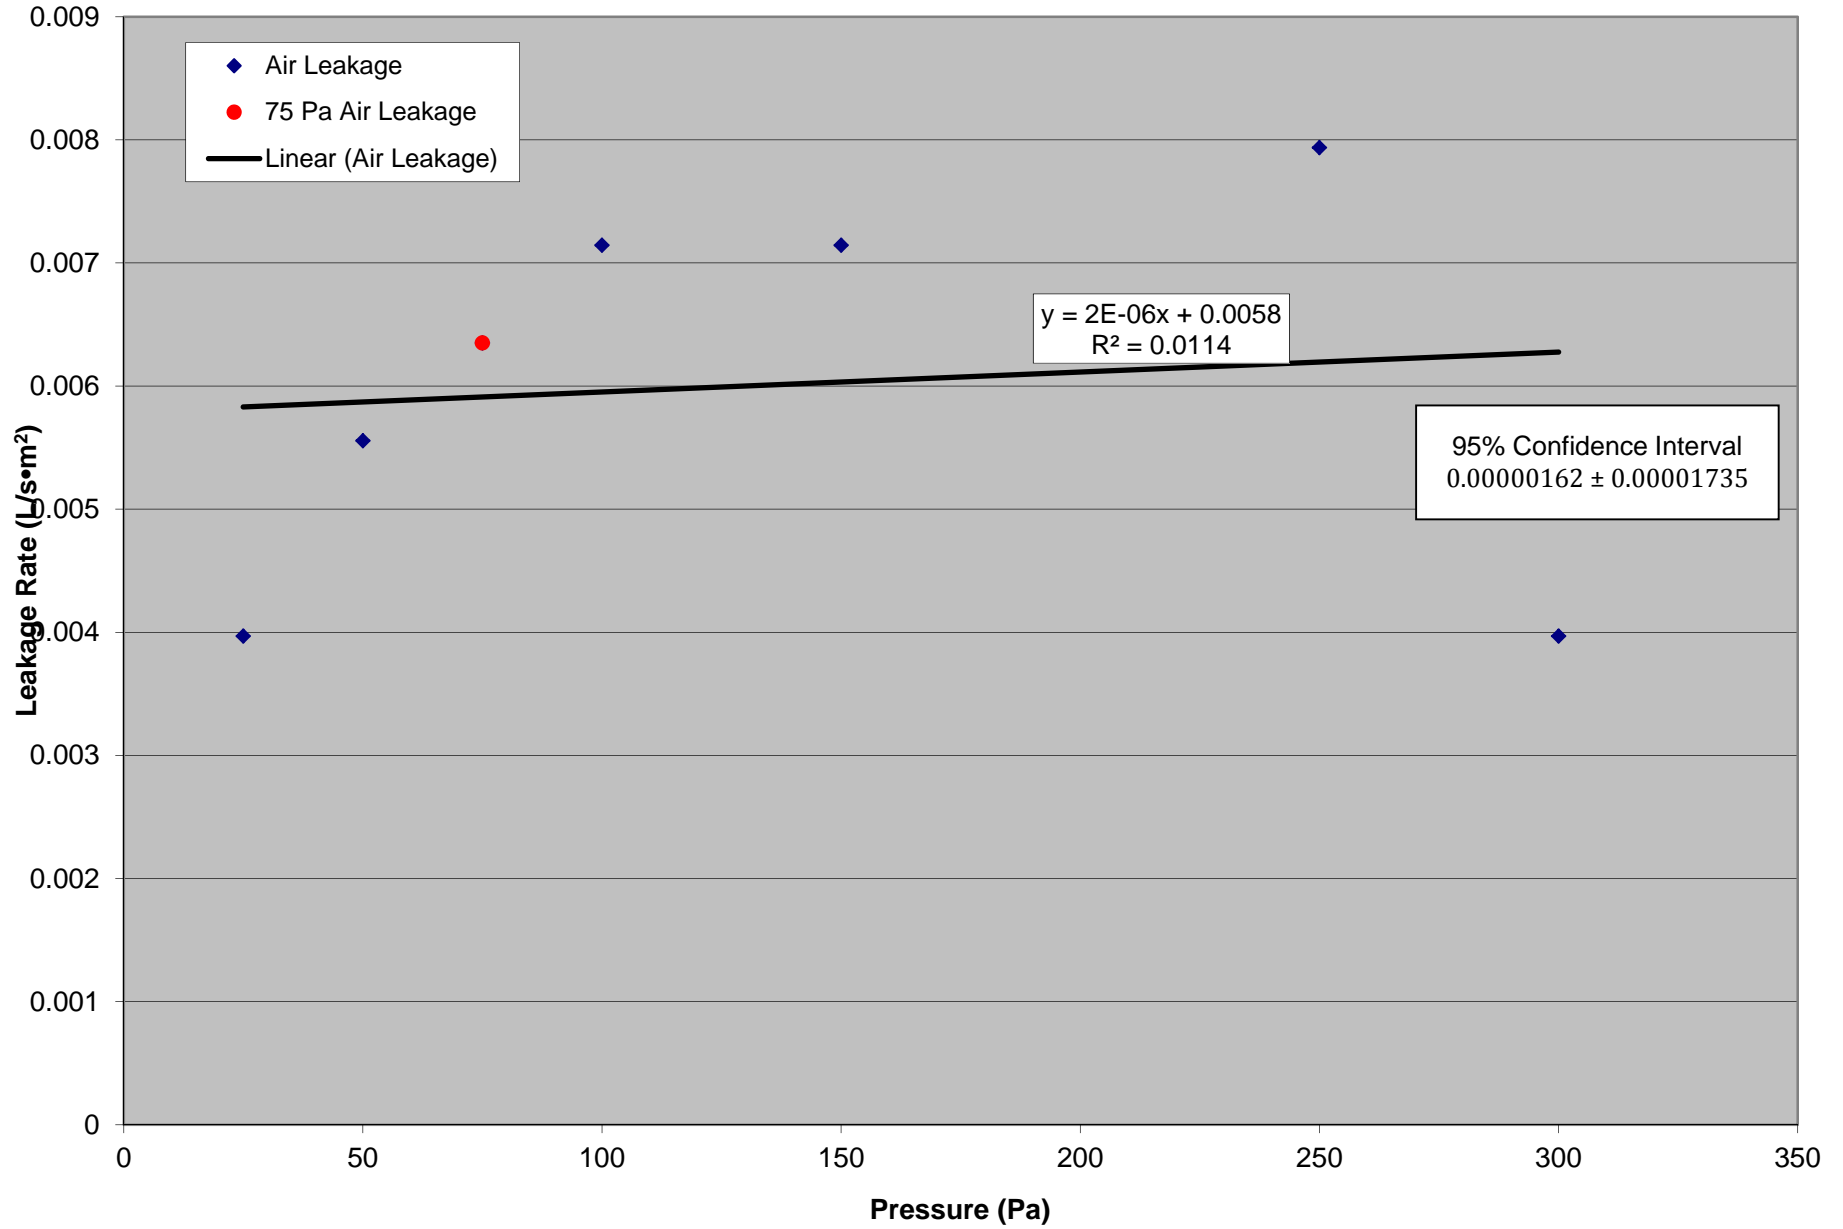
### Specimen #1 - Air Exfiltration (After loading sequence)

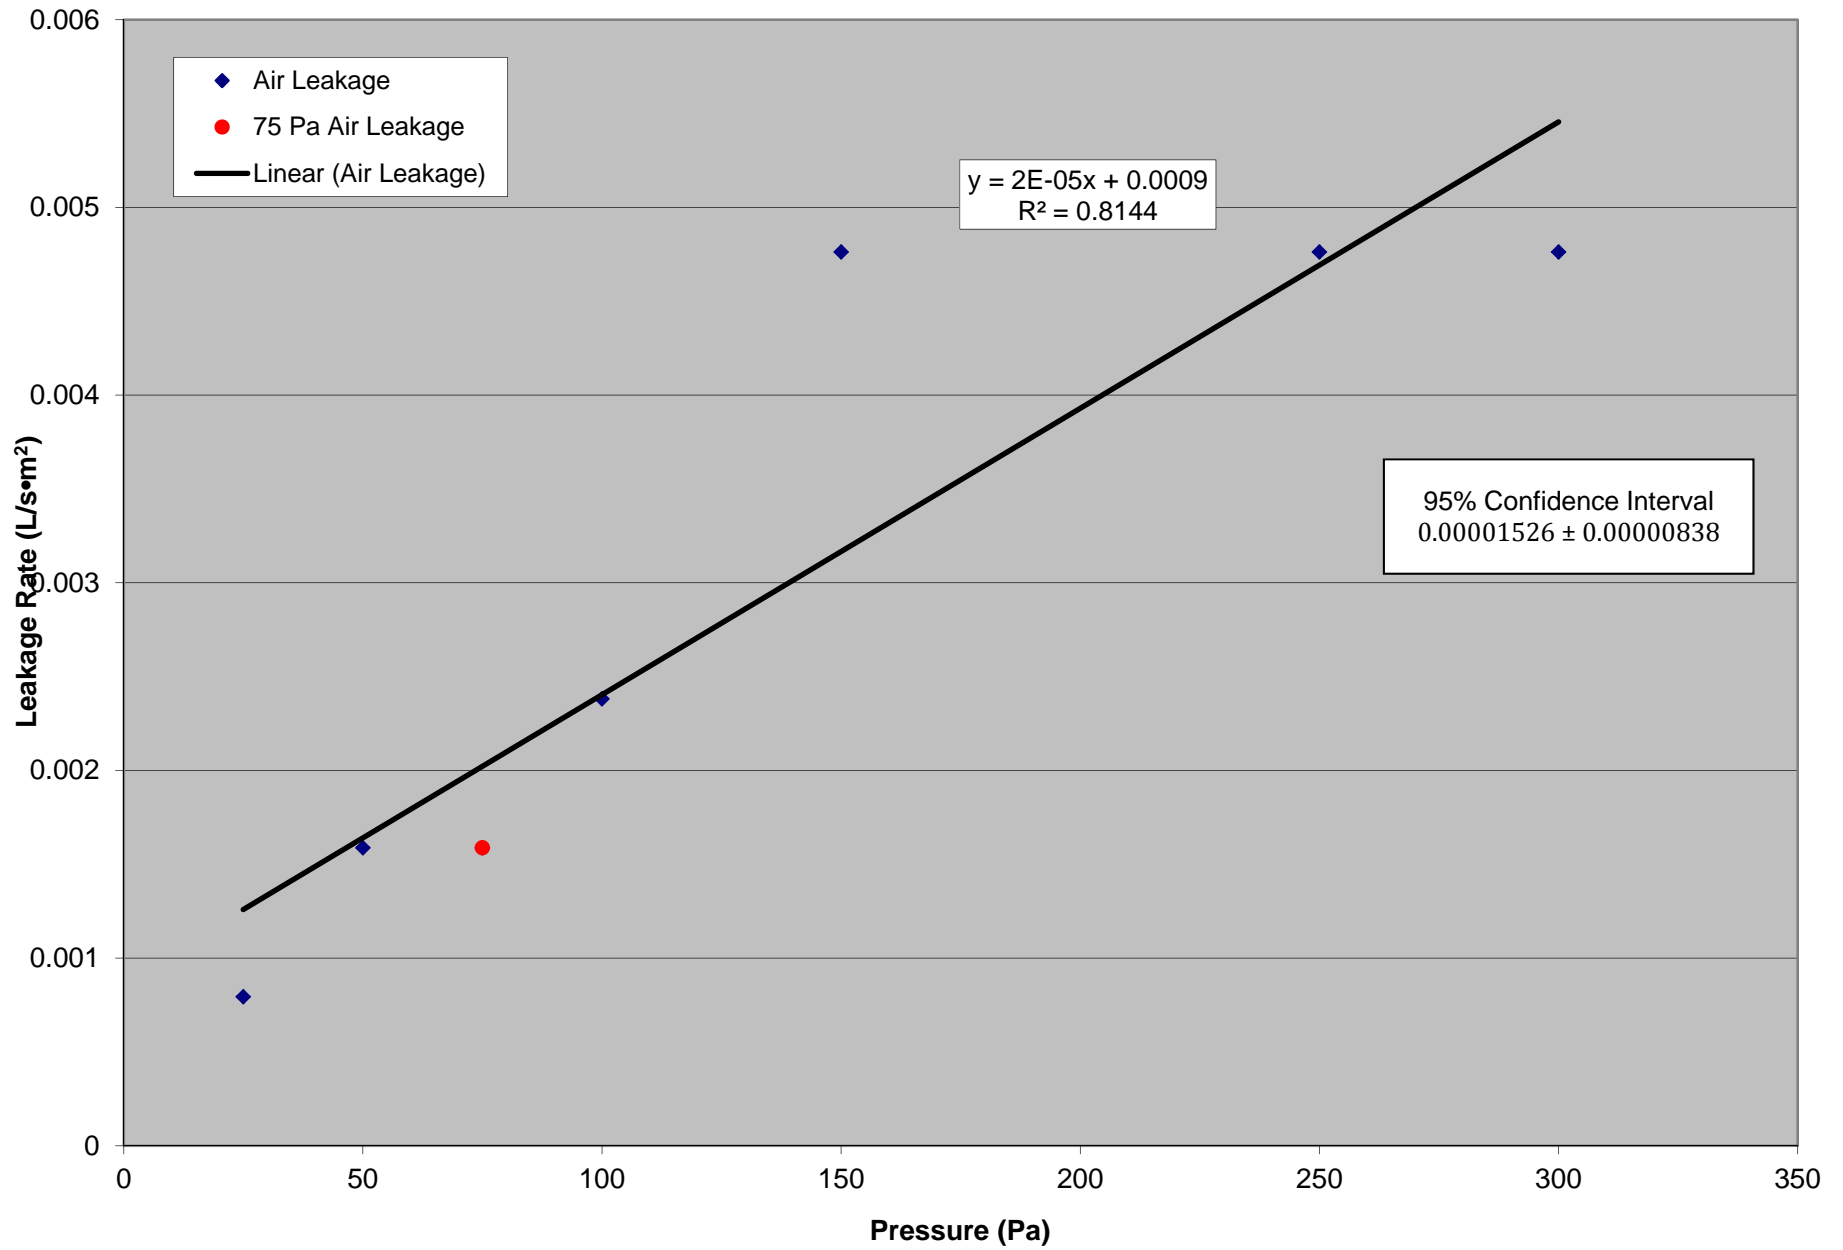
**Specimen #2 - Air Infiltration  
(Before loading sequence)**

<b>Test Results</b>	
<b>Title of Test</b>	<b>Pressure</b>	<b>Air Infiltration</b>	<b>Air Exfiltration</b>
Air Infiltration (Phase I)	25 Pa (0.52 psf)	0.0002 cfm/ft <sup>2</sup> (0.001 L/s/m <sup>2</sup> )	0.0006 cfm/ft <sup>2</sup> (0.003 L/s/m <sup>2</sup> )
	50 Pa (1.04 psf)	0.0003 cfm/ft <sup>2</sup> (0.002 L/s/m <sup>2</sup> )	0.0012 cfm/ft <sup>2</sup> (0.006 L/s/m <sup>2</sup> )
	<b>75 Pa (1.57 psf)</b>	<b>0.0003 cfm/ft<sup>2</sup> (0.002 L/s/m<sup>2</sup>)</b>	<b>0.0017 cfm/ft<sup>2</sup> (0.009 L/s/m<sup>2</sup>)</b>
	100 Pa (2.09 psf)	0.0005 cfm/ft <sup>2</sup> (0.002 L/s/m <sup>2</sup> )	0.0020 cfm/ft <sup>2</sup> (0.010 L/s/m <sup>2</sup> )
	150 Pa (3.13 psf)	0.0009 cfm/ft <sup>2</sup> (0.005 L/s/m <sup>2</sup> )	0.0031 cfm/ft <sup>2</sup> (0.016 L/s/m <sup>2</sup> )
	250 Pa (5.22 psf)	0.0009 cfm/ft <sup>2</sup> (0.005 L/s/m <sup>2</sup> )	0.0038 cfm/ft <sup>2</sup> (0.019 L/s/m <sup>2</sup> )

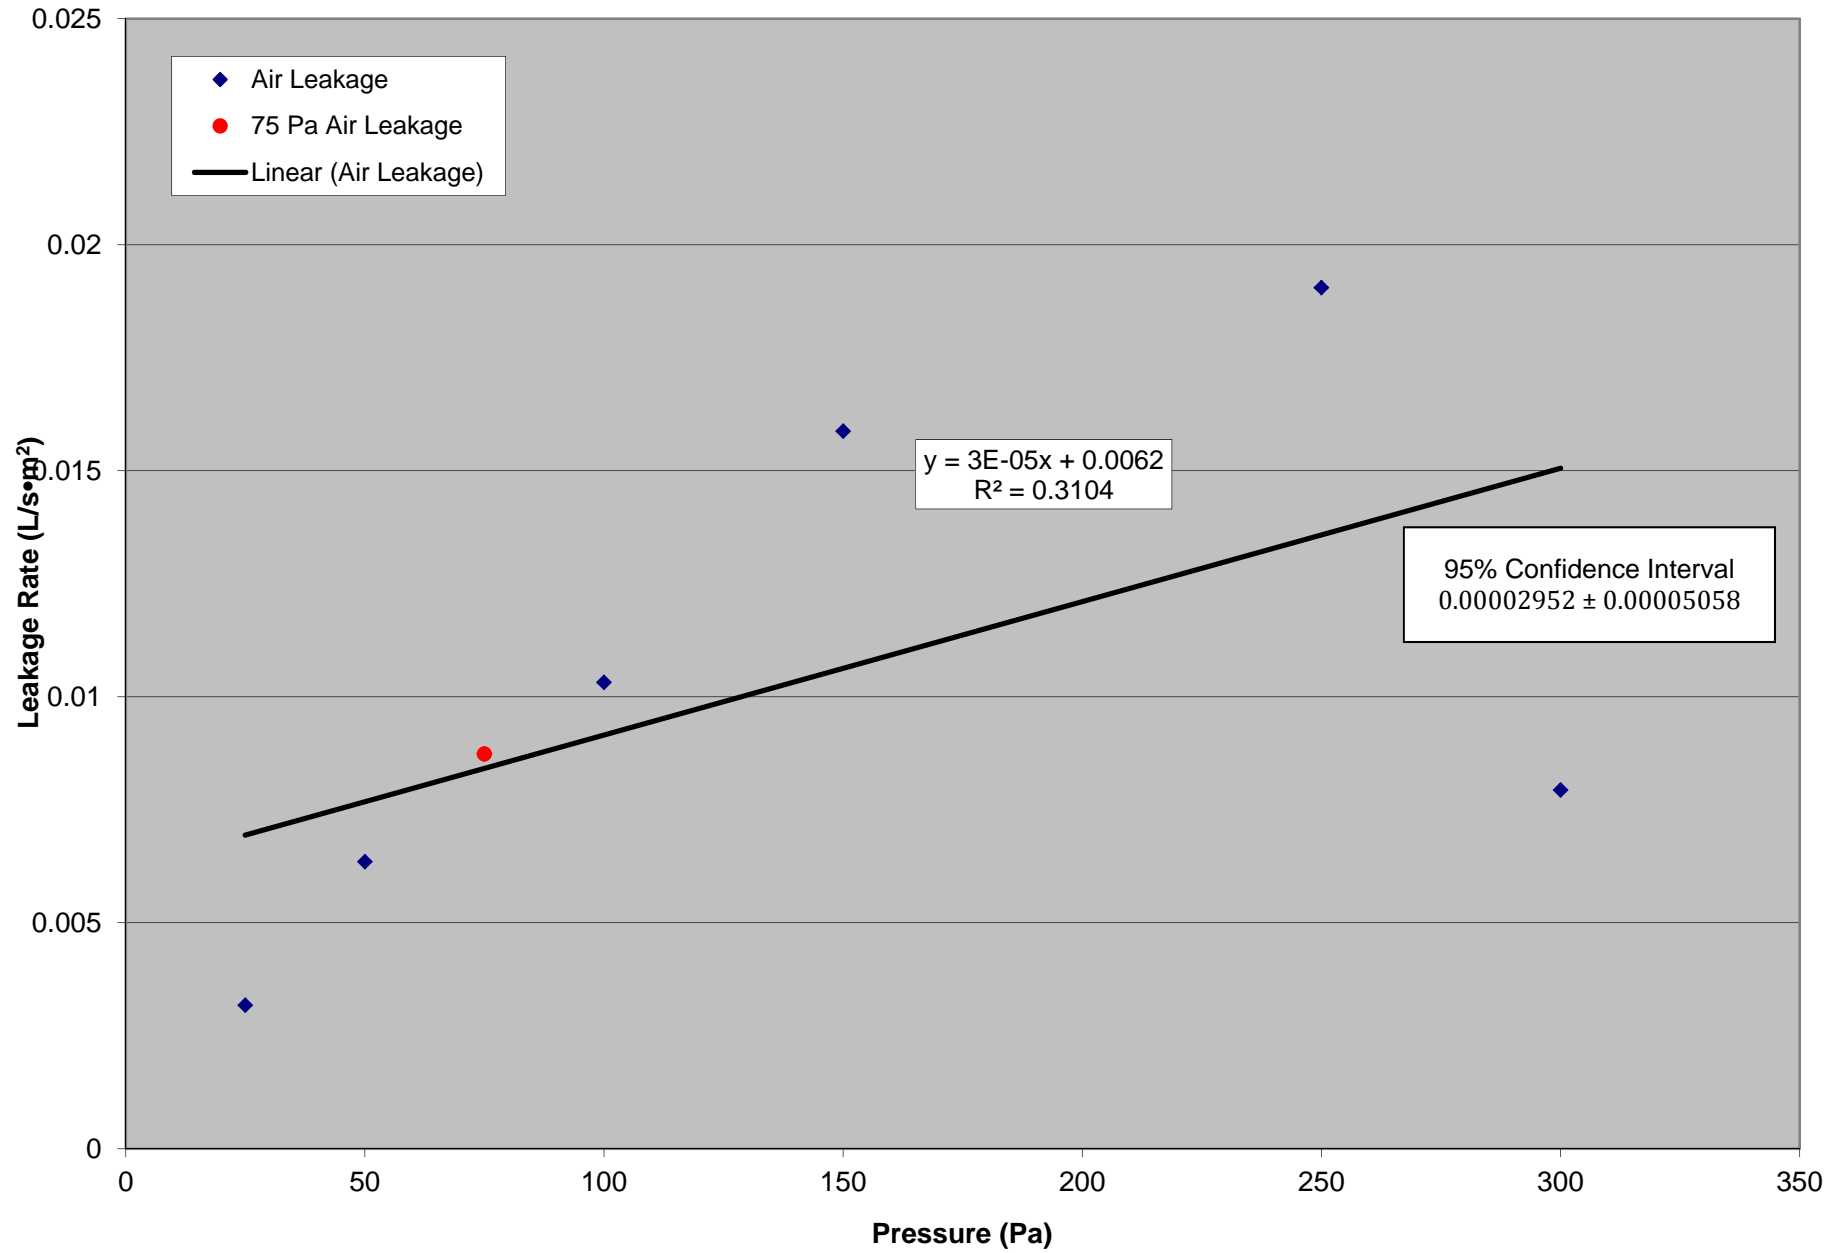
### Specimen #2 - Air Exfiltration (Before loading sequence)

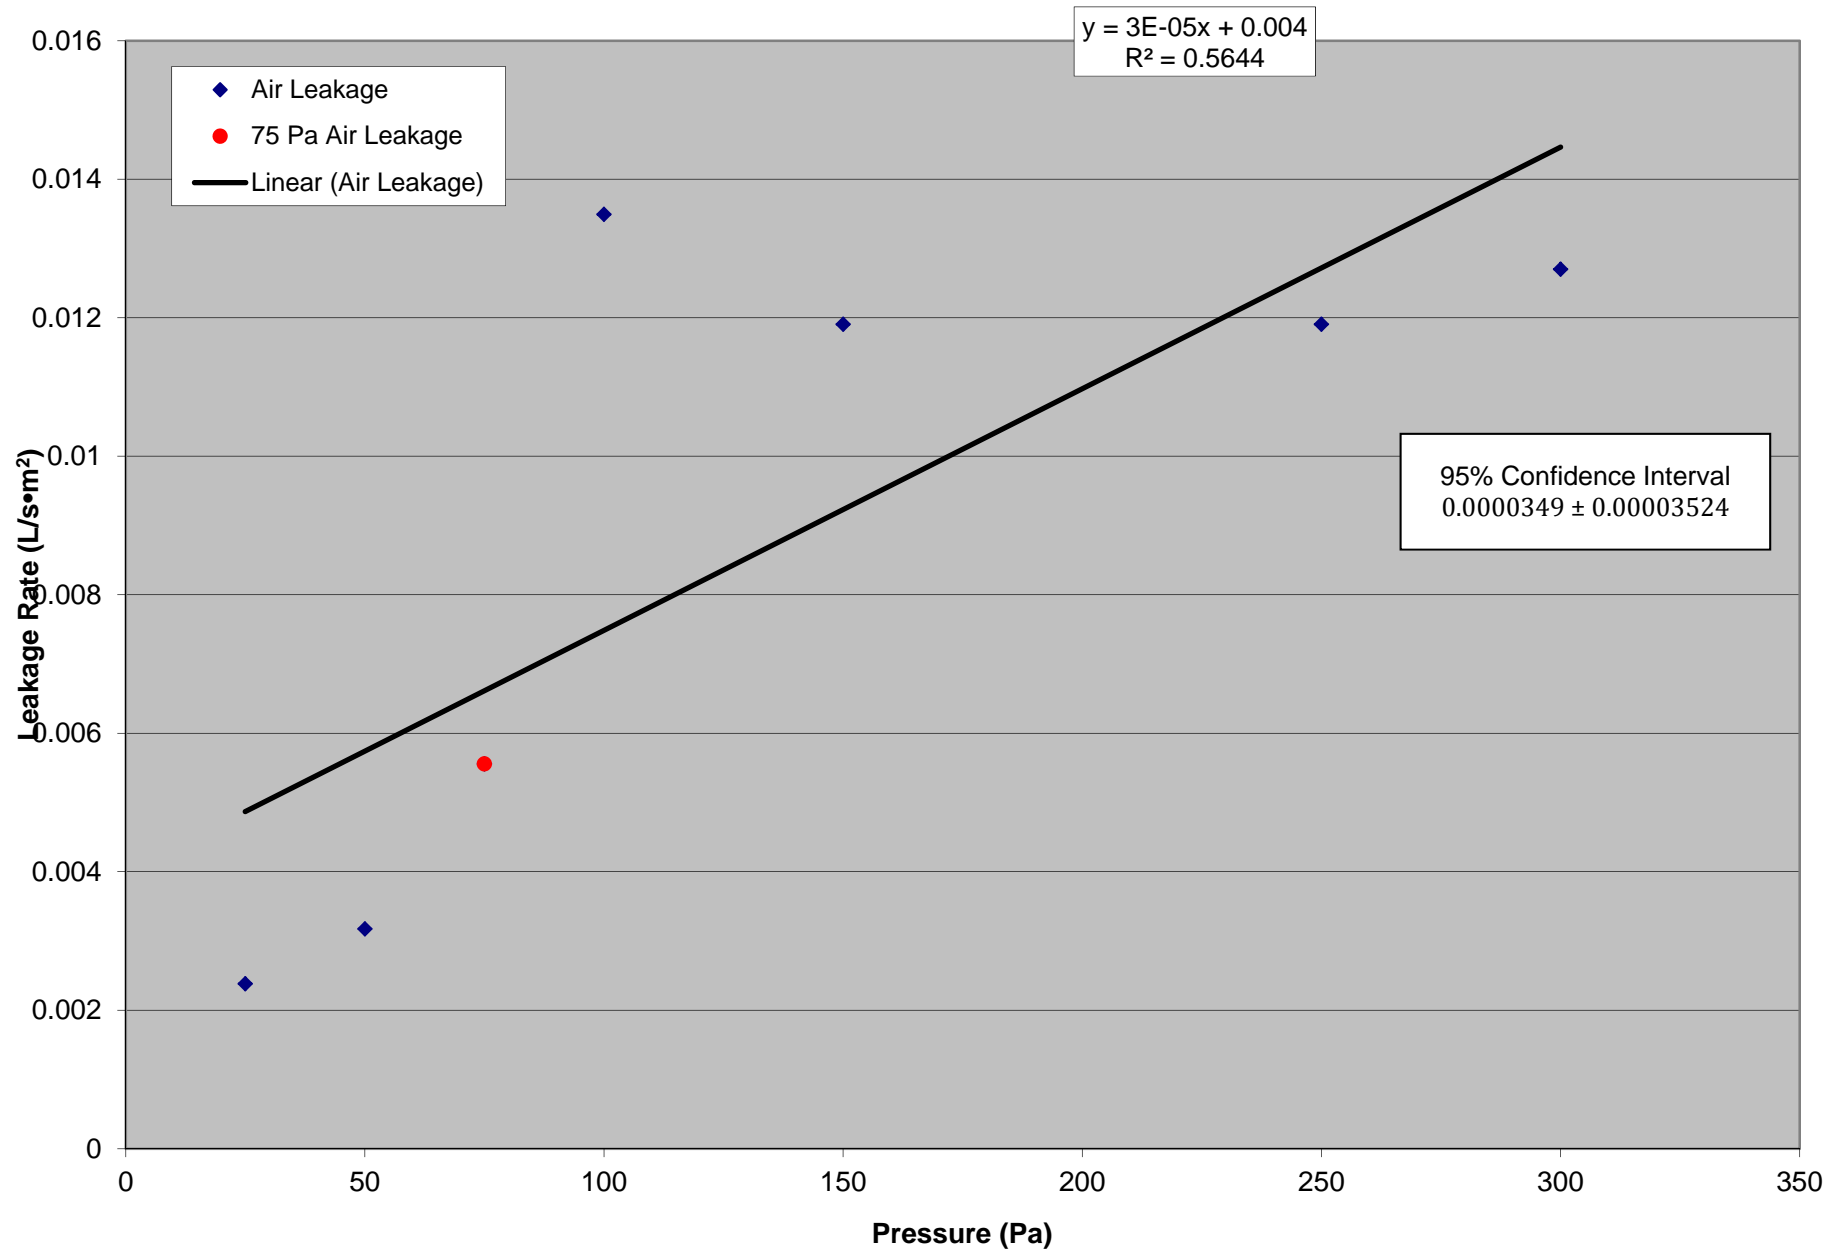
### Specimen #2 - Air Infiltration (After loading sequence)

<b>Test Results</b>	
<b>Title of Test</b>	<b>Pressure</b>	<b>Air Infiltration</b>	<b>Air Exfiltration</b>
Air Infiltration (Phase II)	25 Pa (0.52 psf)	0.0005 cfm/ft <sup>2</sup> (0.002 L/s/m <sup>2</sup> )	0.0006 cfm/ft <sup>2</sup> (0.003 L/s/m <sup>2</sup> )
	50 Pa (1.04 psf)	0.0006 cfm/ft <sup>2</sup> (0.003 L/s/m <sup>2</sup> )	0.0006 cfm/ft <sup>2</sup> (0.003 L/s/m <sup>2</sup> )
	<b>75 Pa (1.57 psf)</b>	<b>0.0011 cfm/ft<sup>2</sup> (0.006 L/s/m<sup>2</sup>)</b>	<b>0.0011 cfm/ft<sup>2</sup> (0.006 L/s/m<sup>2</sup>)</b>
	100 Pa (2.09 psf)	0.0027 cfm/ft <sup>2</sup> (0.014 L/s/m <sup>2</sup> )	0.0014 cfm/ft <sup>2</sup> (0.007 L/s/m <sup>2</sup> )
	150 Pa (3.13 psf)	0.0023 cfm/ft <sup>2</sup> (0.012 L/s/m <sup>2</sup> )	0.0016 cfm/ft <sup>2</sup> (0.008 L/s/m <sup>2</sup> )
	250 Pa (5.22 psf)	0.0023 cfm/ft <sup>2</sup> (0.012 L/s/m <sup>2</sup> )	0.0027 cfm/ft <sup>2</sup> (0.014 L/s/m <sup>2</sup> )

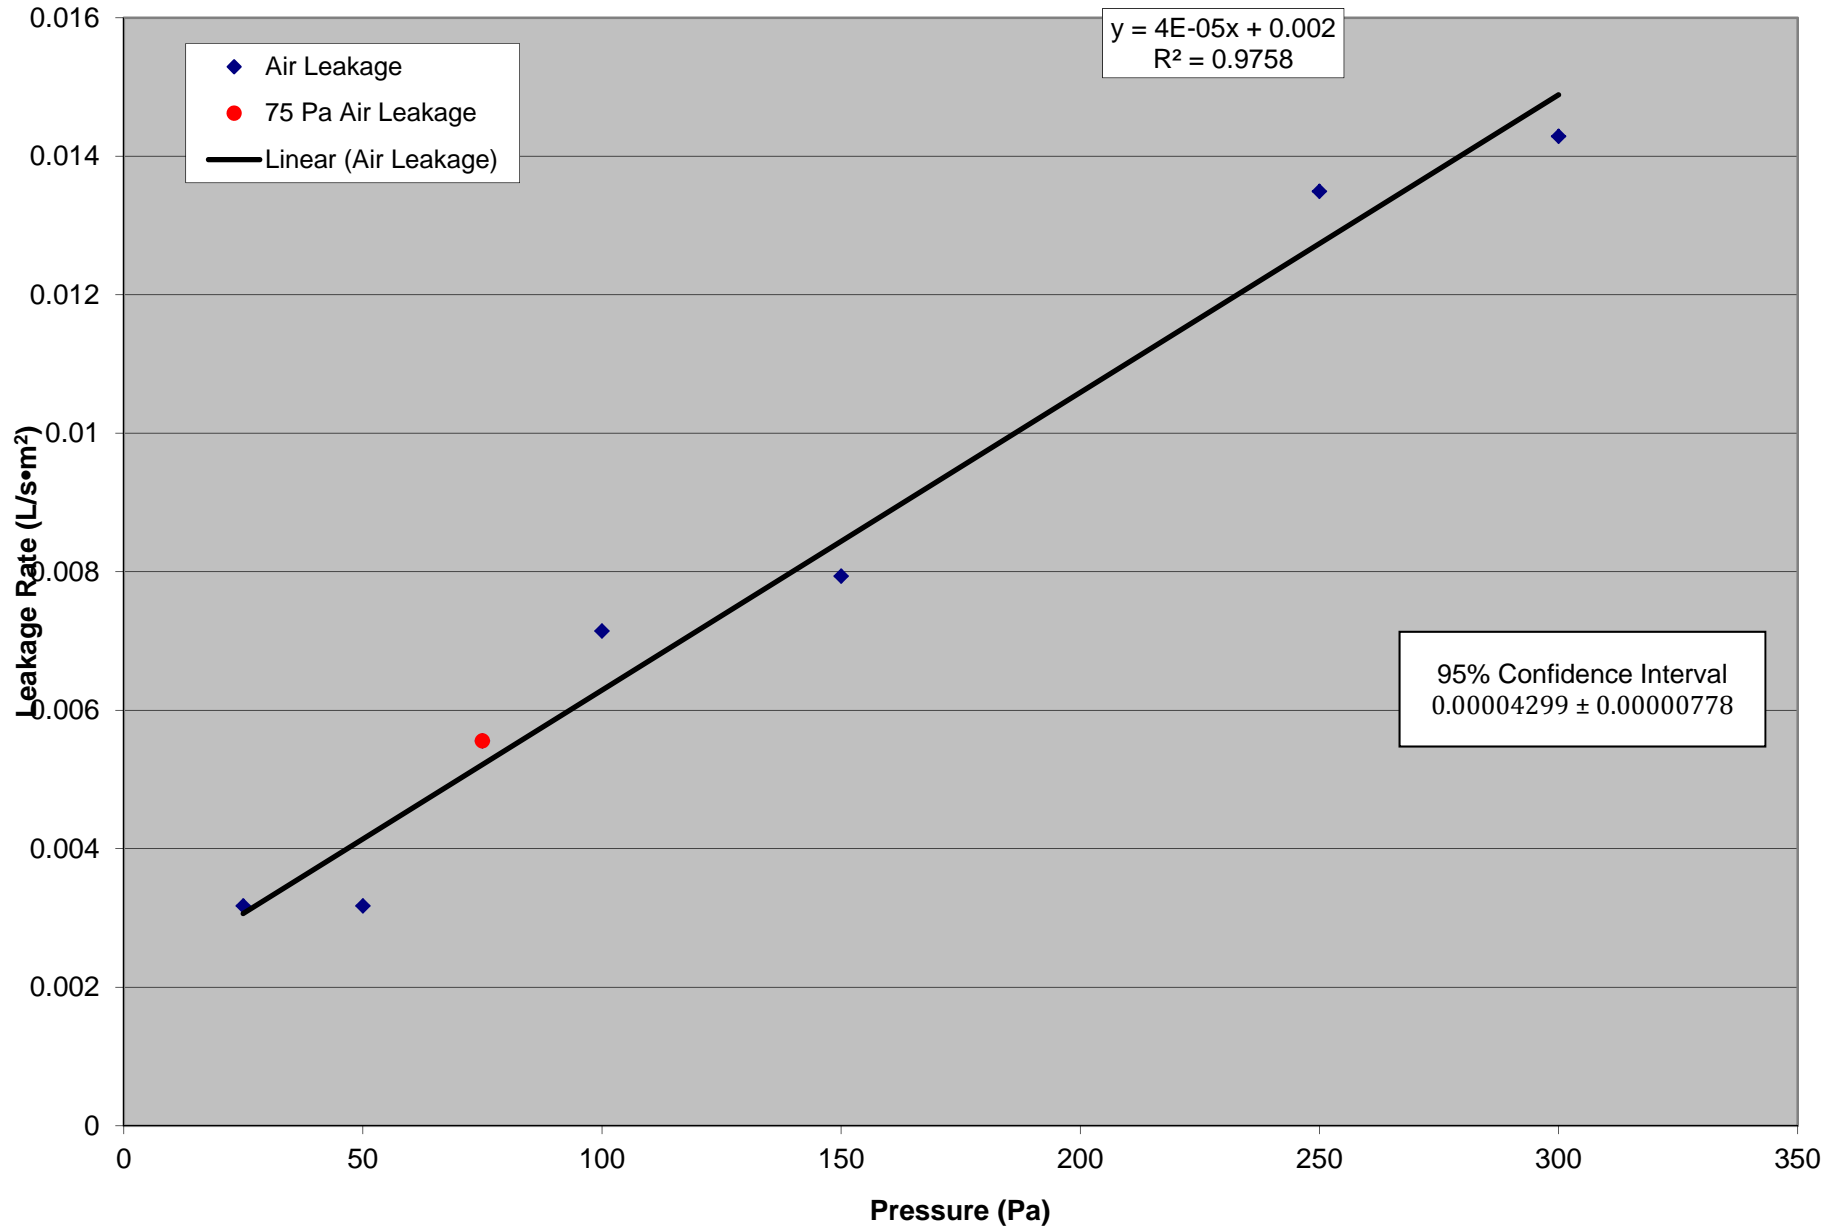
### Specimen #2 - Air Exfiltration (After loading sequence)

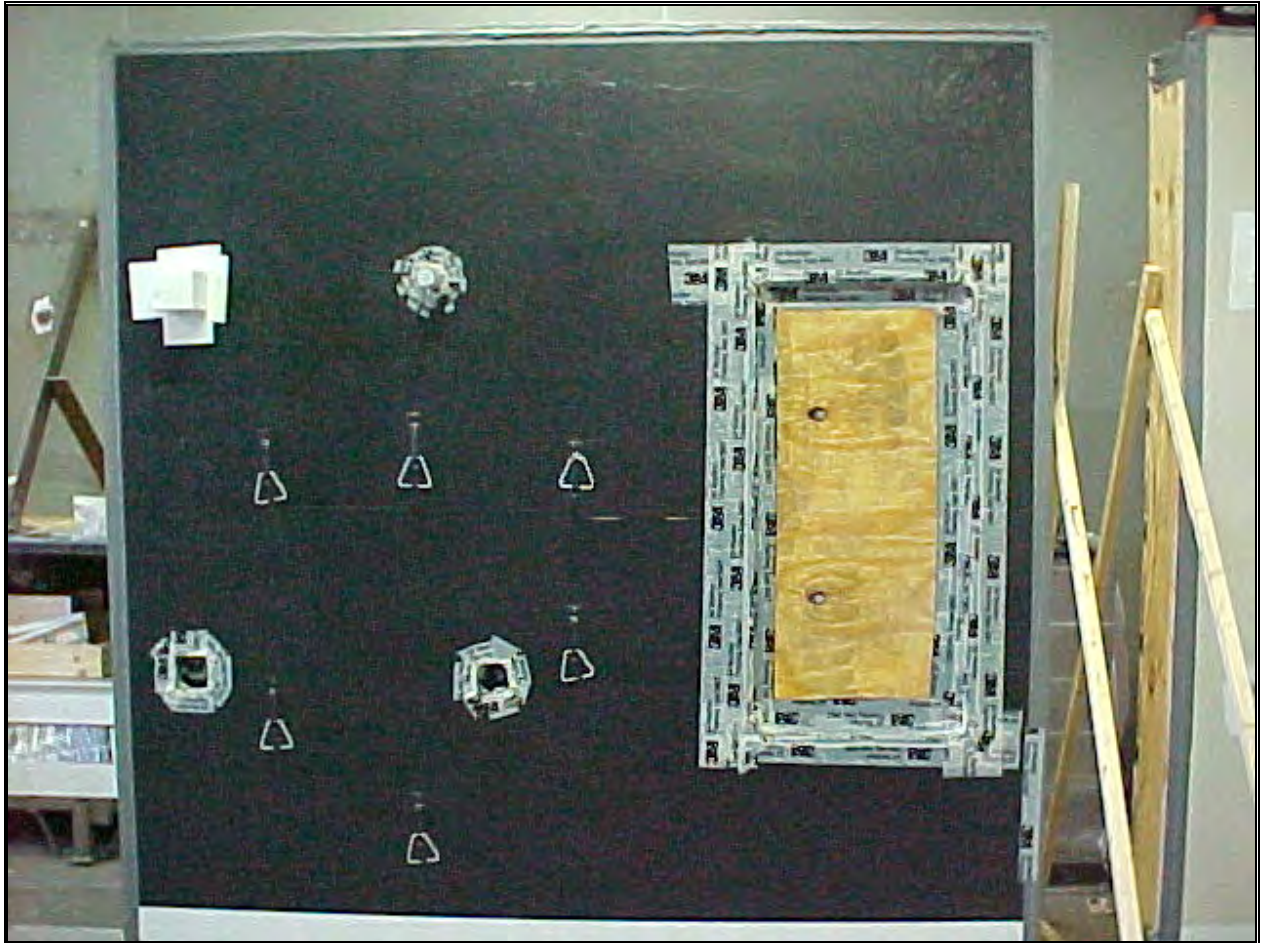
**Photo No. 1**  
**Penetrated Wall**  
**All air seals on the exterior tape / air barrier seal**

**Wall #1 Installation (Penetrated Wall):** Sheathing joints were taped over with Venture VTC 1585CW sheathing tape 3" wide. The assembly was then covered with Bautex Systems, AMB 20-WN primary air barrier material that was spray applied uniformly across the wall at a 32 mil wet thickness average. The assembly/foundation joint was taped over with Venture VB300 Air Barrier Foil 9" width. Penetrations in the assembly included a 24" by 48" window blank, a 4" by 4" duct, a 1-1/2" diameter PVC pipe, and two electrical box penetrations, one square and one octagon per ASTM E 2357. Six masonry anchors were additionally secured to the assembly with #8 x 2" screws before the AMB 20-WN air barrier was applied. The electrical boxes, 1-1/2" PVC pipe, and the perimeter of the window blank were flashed with Venture VB400 tape self-adhering flashing 6" width. The 4" by 4" duct was sealed with Venture VB300 Air Barrier Film. The dry thickness of the Bautex Systems AMB 20-WN primary air barrier material was 22 mil (Reference Photo #1 for details).

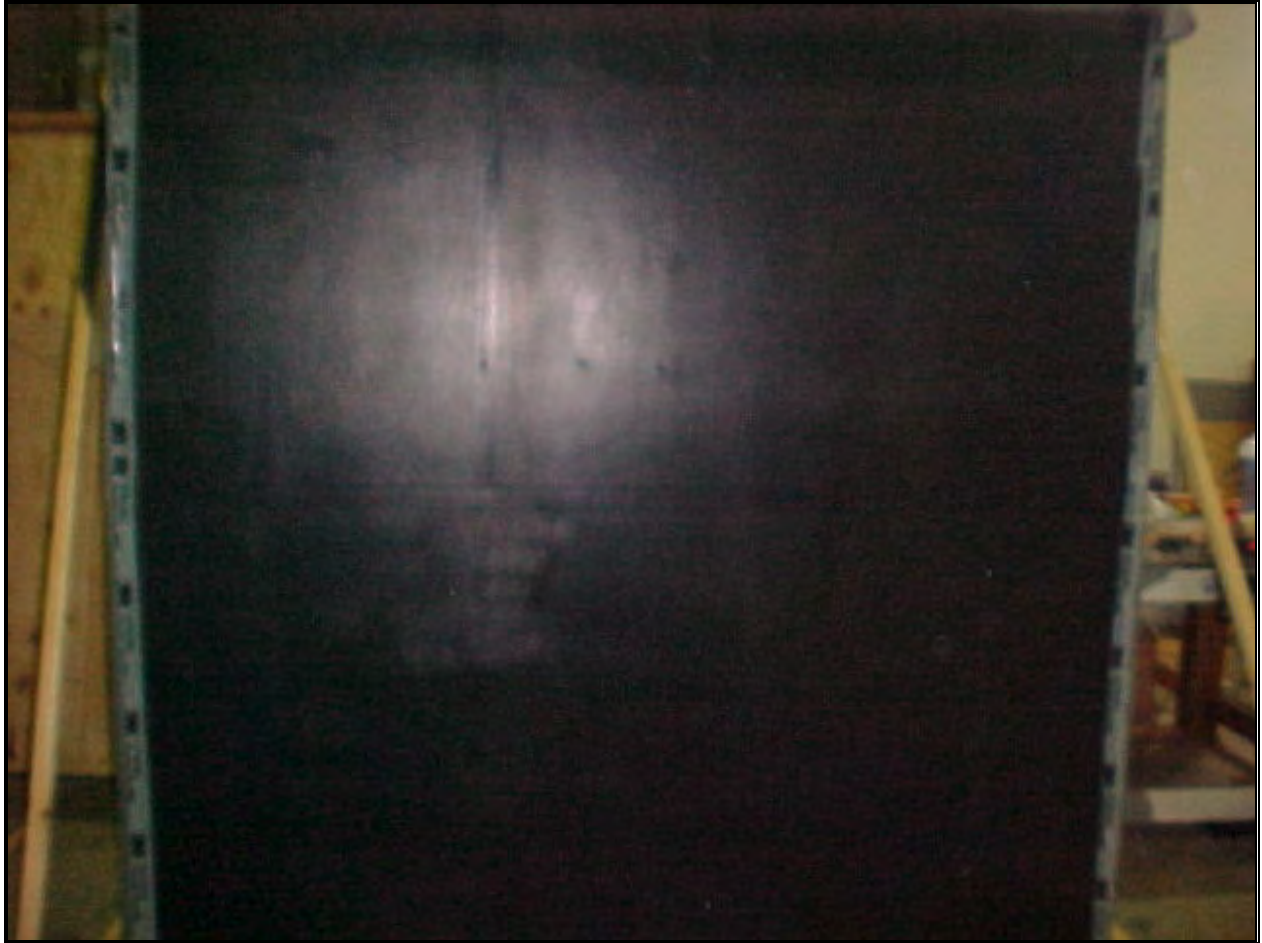
**Photo No. 2**  
**Control Wall**  
**All air seals on the exterior air barrier seal**

**Wall #2 Installation (Control Wall):** Sheathing joints were taped over with Venture VTC 1585CW sheathing tape. The assembly was then covered with Bautex Systems AMB 20-WN primary air barrier material that was spray applied uniformly across the wall at a 32 mil wet thickness average. The dry thickness of the AMB 20-WN primary air barrier material was 22 mil (Reference Photo #2 for details).
